# Asphalt Shingle Sloped Roofing Research Study

Phase 1

This report was prepared by RDH Building Science Inc. for BC Housing and the Roofing Contractors Association of BC. We gratefully acknowledge their support as this study proceeded.

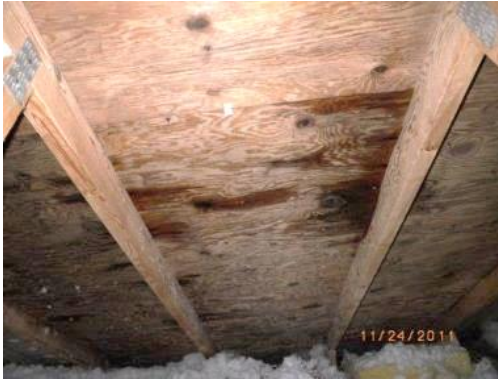
*Figure 1.1 Visibly wet roof sheathing caused by rainwater ingress through the shingles and underlay*

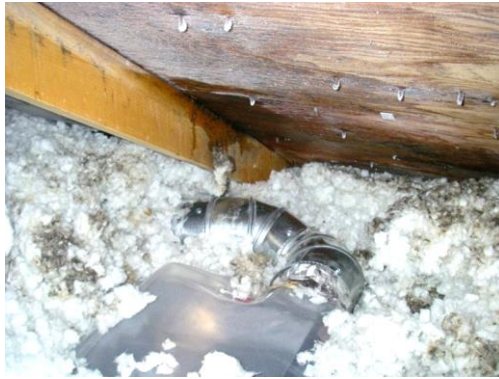
*Figure 1.2 Locally stained and wet sheathing due to condensation (frost) of humid air which is leaking from a poorly sealed bathroom exhaust duct*

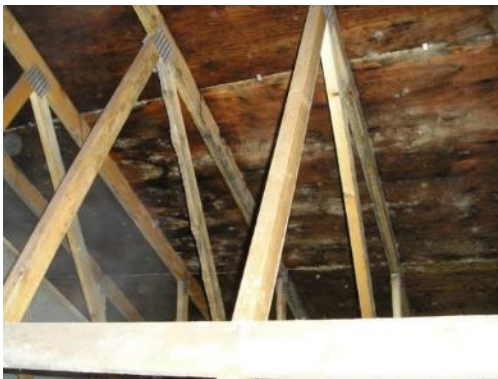
*Figure 1.3 Widespread stained, wet, and deteriorated sheathing within wood-frame attic from persistent indoor and exhaust duct air leakage and poor attic ventilation*

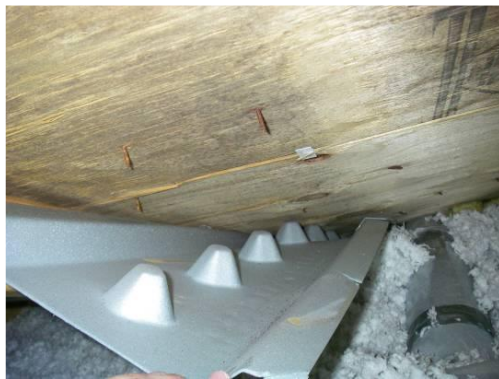
*Figure 1.4 Fungal growth on sheathing within the ventilation baffles as a result of the entrainment of humid, outdoor air*

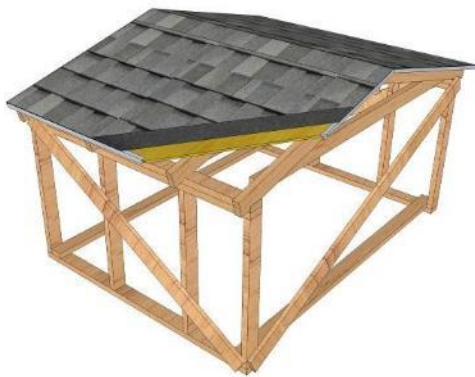
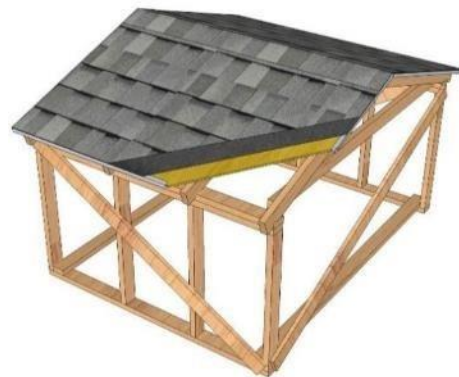
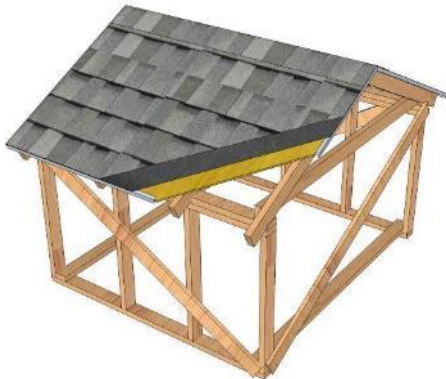
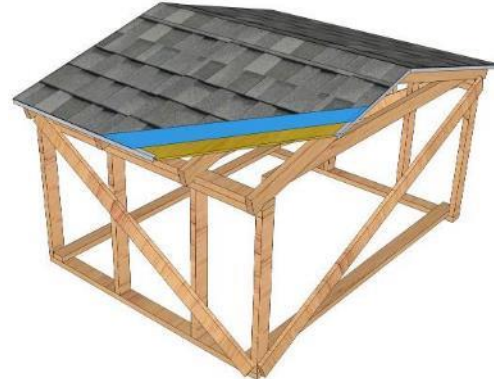
*Figure 1.6 - Schematics of field monitoring roof huts*

a) 3:12 Slope roof with roofing felt underlay

b) 4:12 Slope roof with roofing felt underlay

c) 6:12 Slope roof with roofing felt underlay

d) 3:12 Control roof with SAM underlay

To assess the field performance of wood-frame attic roof assemblies, four roof huts were constructed, each 6 feet wide by 6 feet long in plan dimension. The roof huts were constructed using ½" plywood sheathing, 2x4 wood framing, and dark coloured three-tab shingles as shown in Figure 1.6 to Figure 1.10. Three of the roofs were constructed at 3:12, 4:12, and 6:12 slopes respectively with standard BC Building Code minimum asphalt impregnated #15 roofing paper underlay, while the fourth "control" roof was constructed at a 3:12 slope using an impermeable self-adhered membrane (SAM) underlay.

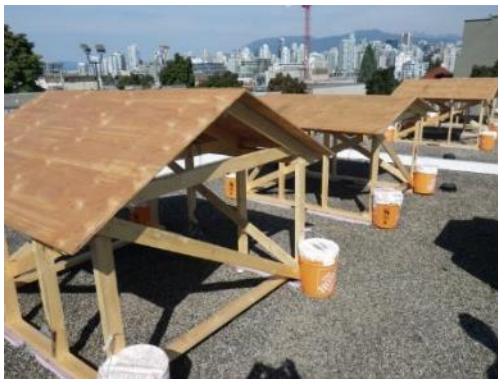
*Figure 1.7 - Roof huts under construction with plywood sheathing installed*

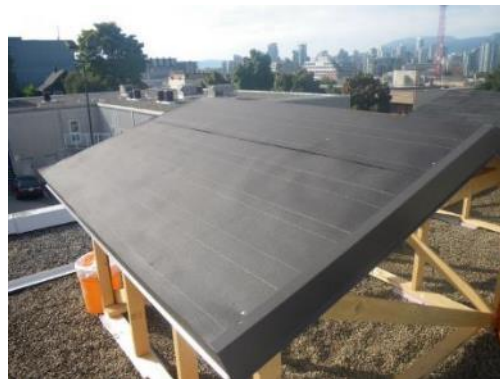
*Figure 1.8 - #15 roofing felt underlay and perimeter flashings installed*

To assess the potential for wetting due to inward vapour diffusion and the potential impact of restricted outward drying, two types of underlayment were considered as part of this research: a permeable #15 roof felt, and an impermeable self-adhered membrane. The vapour permeable #15 roof felt has a vapour permeance that ranges from approximately 0.5 U.S. perms (29 ng/s·m<sup>2</sup>·Pa) under dry conditions up to 30 U.S. perms (1720 ng/s·m<sup>2</sup>·Pa) in wet conditions (Straube and Burnett, 2005). The vapour impermeable self-adhered membrane has a maximum vapour permeance of approximately 0.1 U.S. perms (6 ng/s·m<sup>2</sup>·Pa). An impermeable membrane eliminates any sources of exterior wetting, but also eliminates the potential for outward drying. The vapour permeable membrane allows for some vapour diffusion which may result in some degree of wetting from and drying to the exterior. Photos of the two different underlays were provided previously in Figure 1.8 and Figure 1.9.

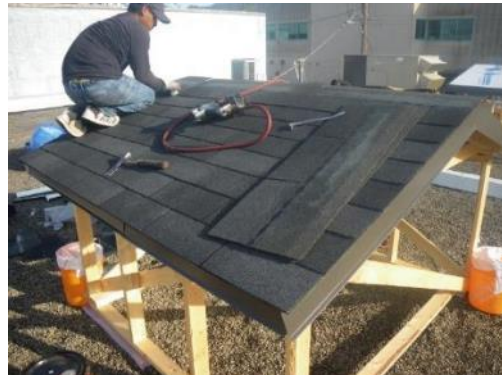
*Figure 1.10 – Three-tab asphalt shingles being installed by roofing contractor*

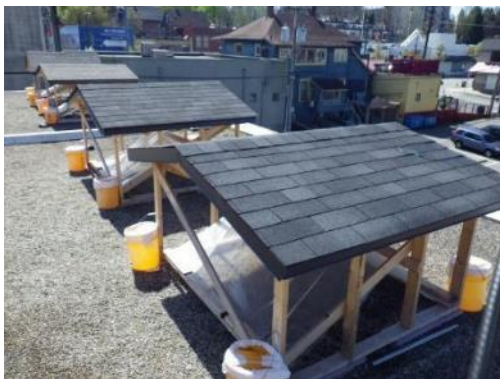
*Figure 1.11 – Completed roof huts in-place on low-slope commercial roof-top. Black three-tab shingles installed on test roofs, dark grey shingles from same manufacturer installed on control roof with SAM underlay*

The roof huts were arranged such that one side of the roof slope faces due North and one side faces South to investigate the impact of solar radiation on performance. The different orientations influence how the roof heats up and dries, and potentially how well the self-sealing stripping of the shingles engages. The arrangement of the roof huts is shown in Figure 1.11 and Figure 1.12.

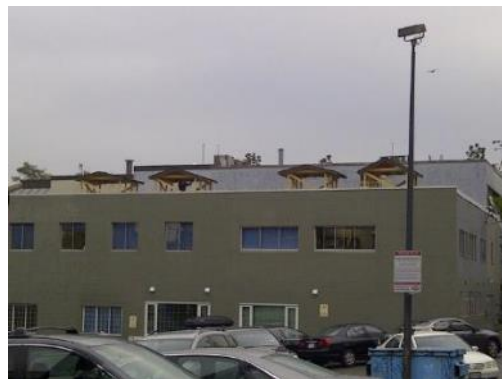
*Figure 1.12 – Exposure of roof huts on top of 2 storey commercial building roof-top. From left to right: 3:12, 4:12, Control (3:12), and 6:12*

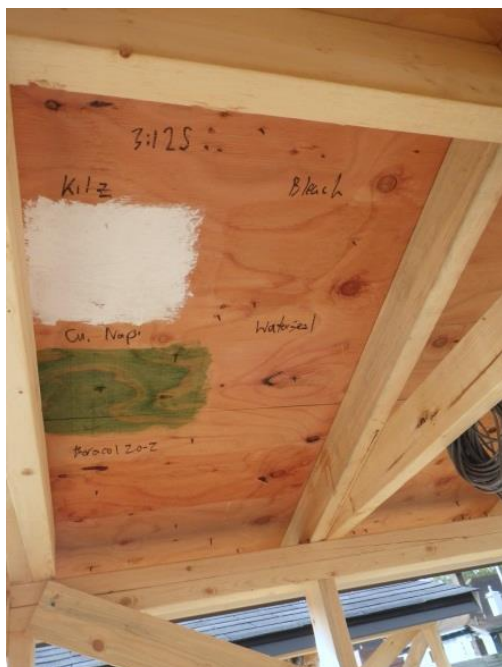
*Figure 1.13 – First round application of surface treatments applied to each roof and slope. From top left, counter-clockwise: Kilz® Paint, Bleach, Thompson's WaterSeal®, Boracol 20-2, Copper Naphthenate*

Boracol® is produced by Sansin Corporation and the original 20-2 formulation is a wood preservative/fungicide whereas the 20-2 BD formulation has an added mouldicide effect over the 20-2. Figure 1.13 and Figure 1.14 show these surface treatments as initially applied to the roof sheathing. Note that the second round of wood treatments were applied to the sheathing when mould growth may have already been present.

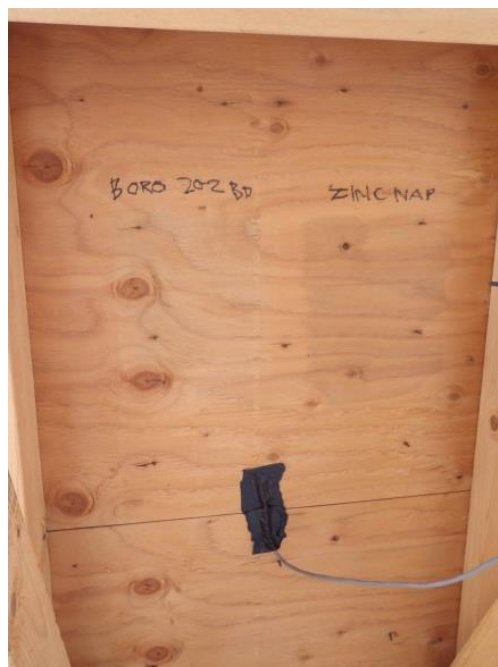
*Figure 1.14 – Second round application of surface treatments applied to each roof and slope. Boracol 20-2 BD (left) and Zinc Naphthenate (right)*

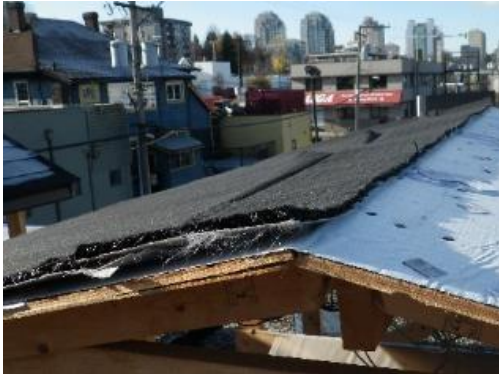
Figure 1.15 New vented drain-mat layer installed over the existing self-adhered membrane in the control roof

In Part 2 of the testing, the control roof was modified to include a ventilation layer between the shingles and the self-adhered impermeable membrane. This was achieved by the removal of the shingles from the roof, sealing of nail holes in the existing membrane, and then installing a vented ½” drain mat, 3/16” asphalt board, and new shingles. This modification was made in November 2013 and the roof assembly including the drain mat is shown in Figure 1.15 and Figure 1.16.

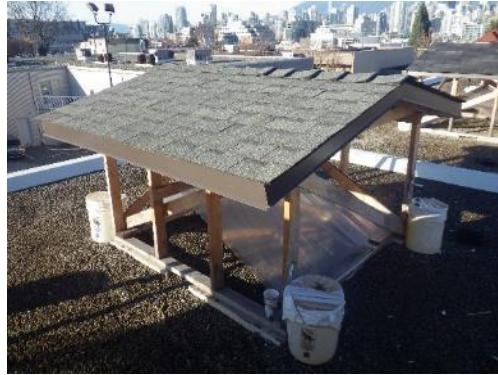
Figure 1.16 New control roof with vented layer under new shingles. Vent openings are provided at the eaves.

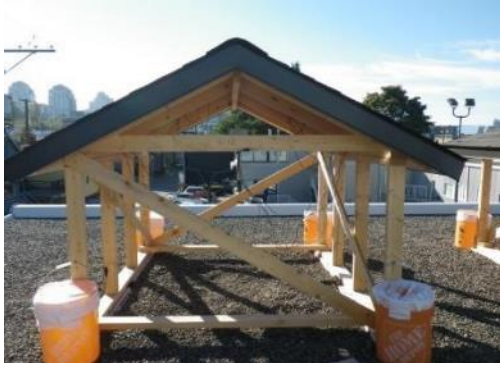
Figure 1.18 – Overview of 6:12 roof hut South (left) and North (right) slopes

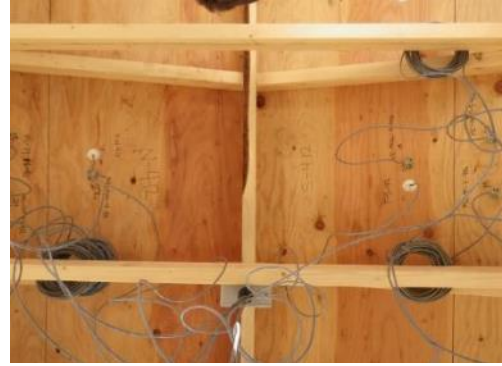
Figure 1.19 – View of underside of 4:12 roof hut showing placement of moisture pins and sheathing temperature sensors

To monitor the moisture content of the plywood sheathing, moisture pins were installed. The placement of the moisture pins is critical in observing how wetting occurs; therefore three sets of moisture pins were installed on each orientation of each test roof. The first set of moisture pins penetrates through all layers of the plywood in order to detect the worst-case moisture content in the sheathing. The second set of moisture pins is insulated and only exposed at the upper layers (outer 1/8") of the plywood to measure wetting at the shingle side. The third set of moisture pins penetrates only the bottom layers (inner 1/8") of plywood to measure wetting at the underside (i.e. night sky condensation). This arrangement of various moisture pin depths allows for the monitoring of how moisture migrates through the plywood sheathing. The sensors are placed near the centre of the panels to eliminate edge effects. A standard gap in the roof sheathing is located above the sensors and represents a possible water penetration point. A temperature sensor for moisture content calibration is installed within a small hole drilled into mid-depth of the plywood. Figure 1.17 shows a schematic of the moisture pin installation into the plywood and Figure 1.18 through Figure 1.21 show photographs of the initially installed moisture content and temperature sensors.

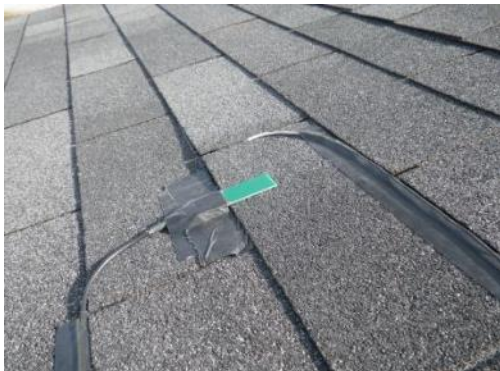
Figure 1.22 – Condensation sensor and surface temperature sensors installed in March 2013 to shingle side of roof

Additional surface temperature, moisture content, and condensation sensors were installed in March 2013 to collect data to show night sky cooling effects and the potential for condensation/rain on the exterior of the shingles and interior surface of the plywood. The sensors were installed on the North and South slopes of the 3:12. Photographs of the installed condensation sensors are shown in Figure 1.22 and Figure 1.23. Additional moisture content sensors were installed in May 2013. These sensors were installed using conductive epoxy to provide improved contact between the moisture pins and the plywood substrate, and like the "inner" moisture pins, these were installed to measure the moisture content of the surface and inner 1/8" of the sheathing. The arrangement of these additional pins is shown in Figure 1.17.

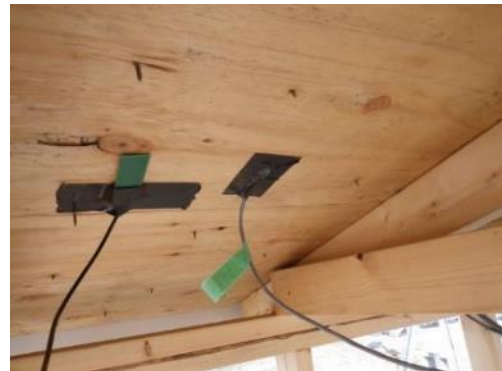
Figure 1.23 – Condensation sensor and surface temperature sensors installed in March 2013 to interior side of sheathing

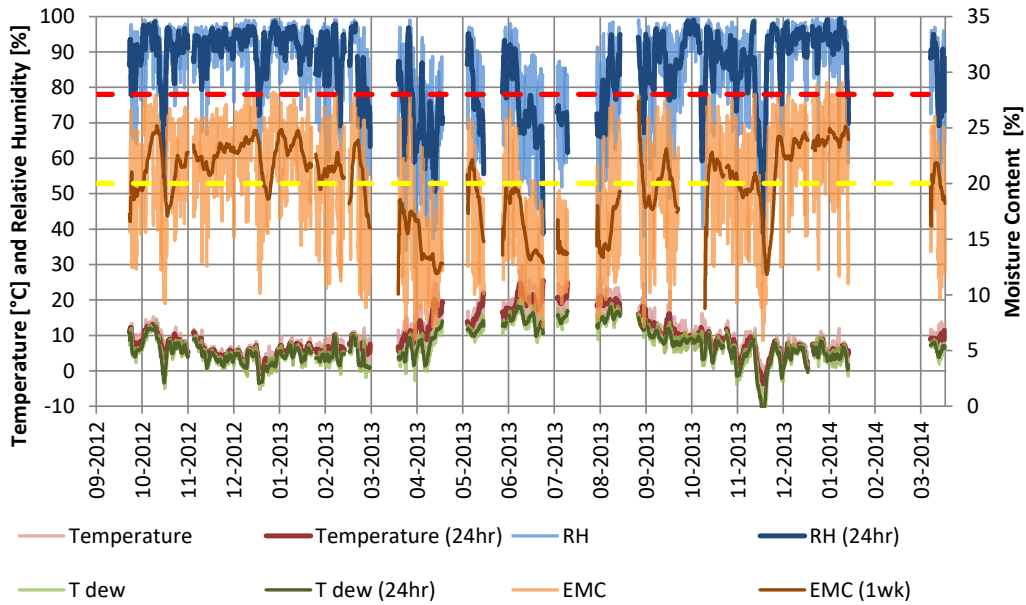
Figure 2.1 Temperature, Relative Humidity, and Equivalent Moisture Content

The temperature and relative humidity were measured throughout the duration of the monitoring period and are provided in Figure 2.1. The moisture content of wood varies with the relative humidity level to which it is exposed even in the absence of condensation or other wetting mechanisms. Consequently, using the Hailwood-Horrobin (1946) correlation, the equivalent moisture content (EMC) of the plywood sheathing can be calculated based on ambient temperature and relative humidity. This is also plotted in Figure 2.1 to demonstrate the moisture content that wood would naturally experience under these environmental conditions without additional wetting or drying.

Reviewing the climatic data shows that the EMC exceeds 20% moisture content throughout the winter due to natural exterior temperature and humidity levels even in the absence of wetting or drying forces. Wetting and drying mechanisms, however, have the ability to both increase and decrease the moisture content of the wood relative to EMC levels. These potential wetting and drying mechanisms included precipitation and solar radiation which are plotted in Figure 2.2.

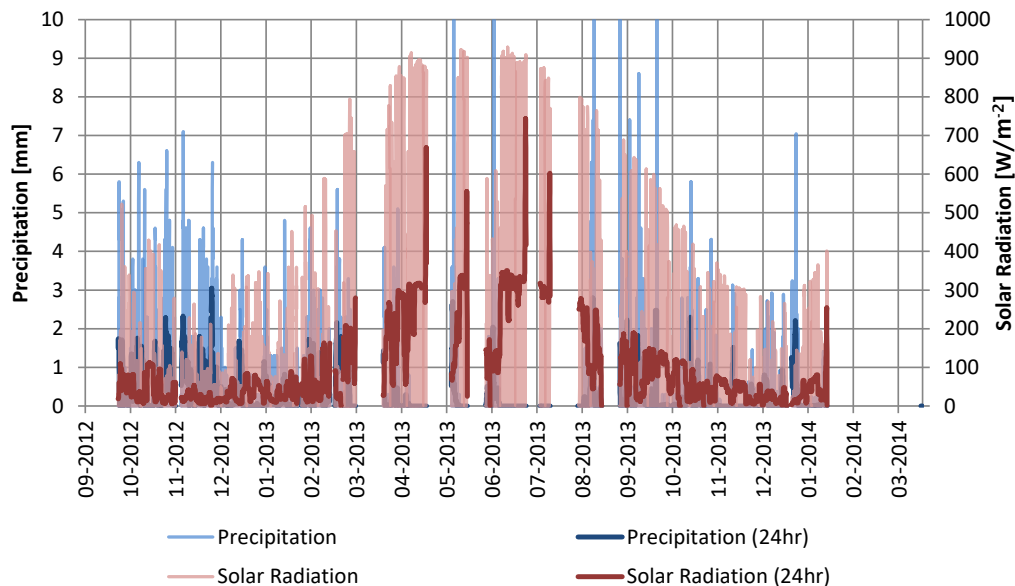
Figure 2.2- Precipitation and Solar Radiation

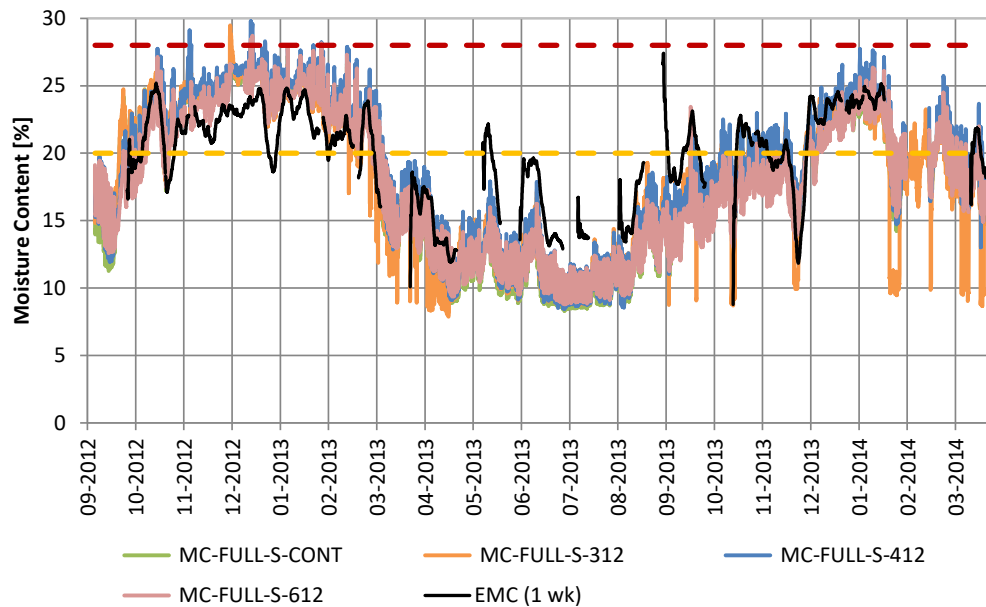
Figure 2.3- Moisture Content of Plywood Sheathing – South, Full Depth Pins – Year 1

The moisture content of the plywood in all of the roof huts appears to be most influenced by the ambient outdoor equilibrium moisture content levels. Moisture contents at all locations range between 20% and 30% during the rainy fall through spring months of October through April. The plywood moisture content at the start of the monitoring period in early fall started at 15% MC on average, increasing to above 20% in October, up to 30% at worst case conditions in December and January. The moisture content is consistently maintained at cautionary levels for fungal contamination (above 20%) for the entire winter period. These high moisture contents are consistent with monitored data from other projects in the Lower Mainland.

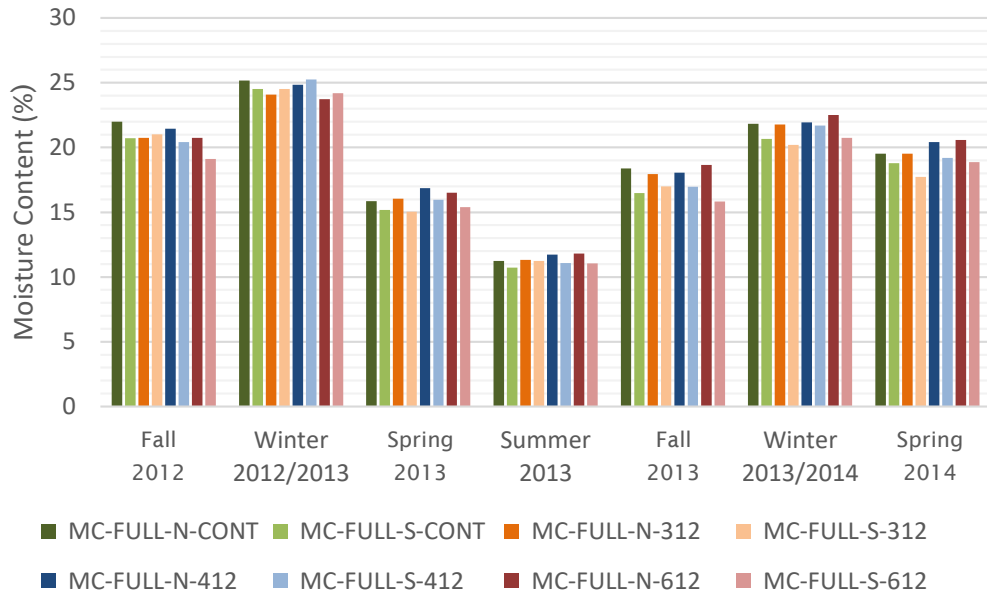
Figure 2.5- Seasonal Average Sheathing Moisture Content for North and South Elevations-Full Depth

Figure 2.5 provides the average seasonal moisture contents of the sheathing for each of the roof huts for the full depth moisture content sensors in both the North and South orientation. Figure 2.6 and Figure 2.7 show the results for the inner and outer sheathing moisture content pins respectively.

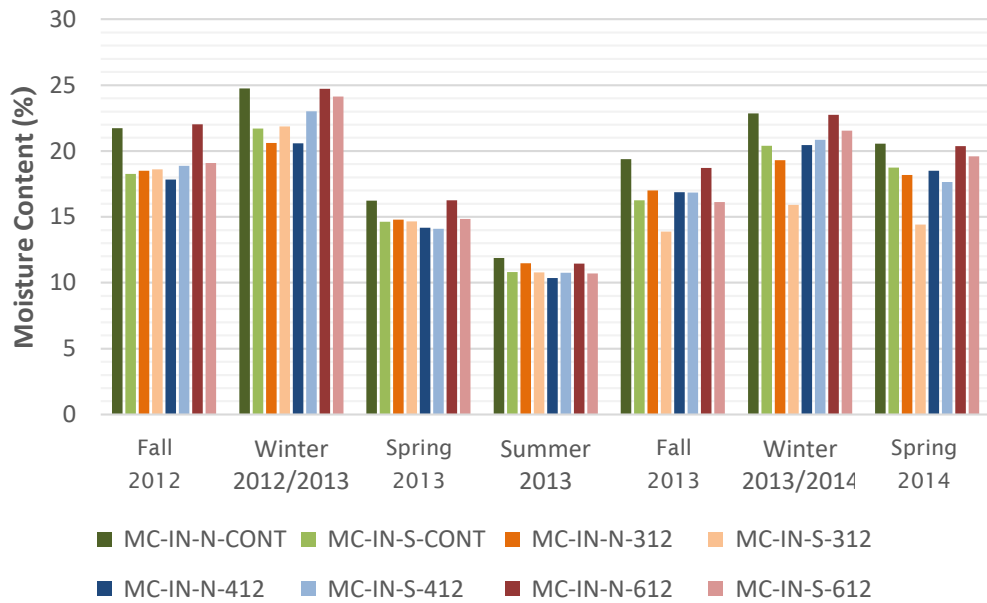
Figure 2.6- Seasonal Average Sheathing Moisture Content for North and South Elevations-Inner 1/8" Depth

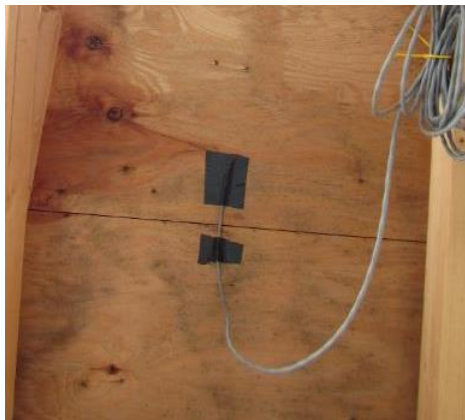
*Figure 2.9 Fungal growth on the underside of the North orientation of the 4:12 roof including two areas with surface treatments which are discussed in later section of this report*

As a result of these prolonged periods of elevated moisture contents, one would expect that fungal growth would occur on the underside of the roof sheathing. This anticipated fungal growth was confirmed visually on all of the test roofs as shown in Figure 2.8 and Figure 2.9. The wetting and drying mechanisms which cause the observed moisture contents and resultant fungal growth are examined in the following section.

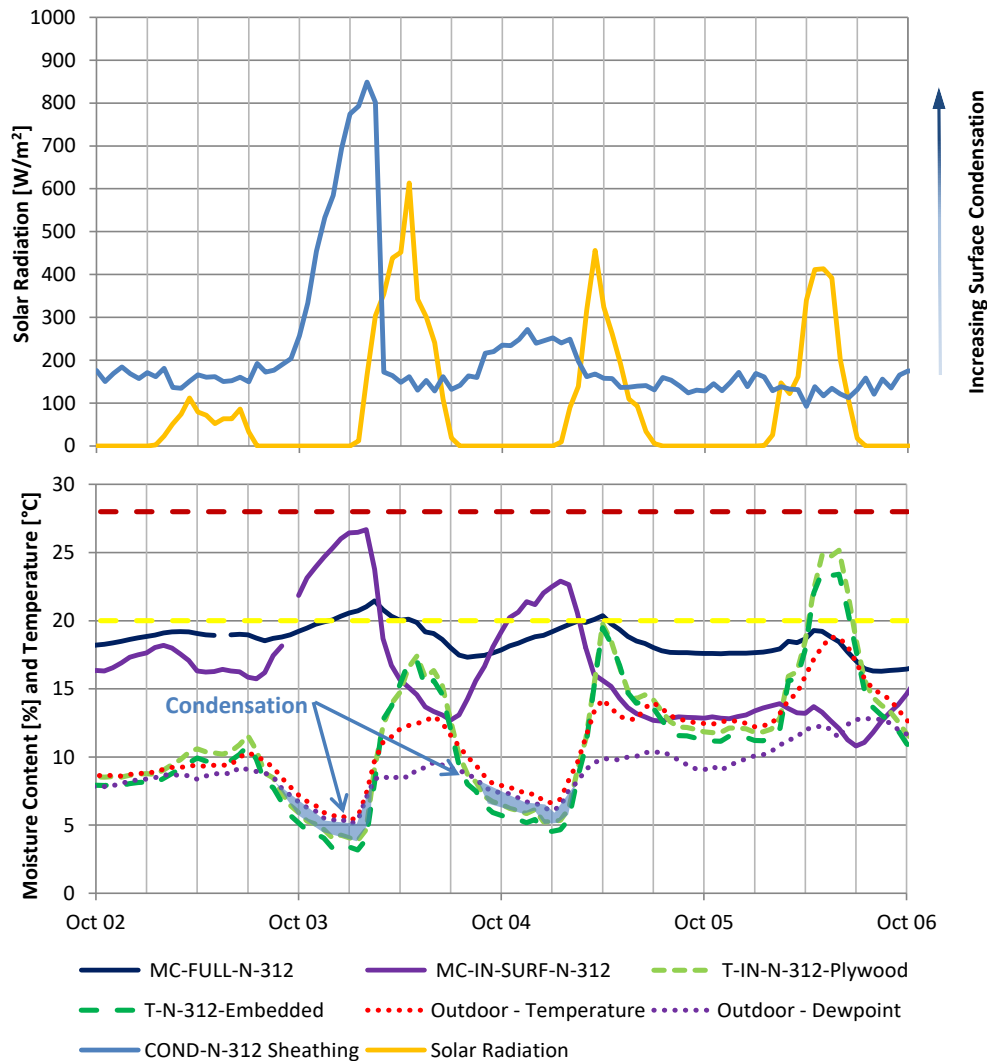
Figure 2.10 – Diurnal temperature and moisture content variation in the North 3:12 roof on October 2 to October 6, 2013.

To examine these potential wetting and drying mechanisms, moisture contents and temperatures were analysed. Figure 2.10 shows the diurnal temperature and moisture content variations of the 3:12 North facing roof for two nights that experience condensation (October 3 and 4), and others that do not experience condensation. Instances when the interior surface temperature of the sheathing drops below the dew point temperature of the ambient air are highlighted in blue and indicate instances when condensation would theoretically occur on the underside of the sheathing.

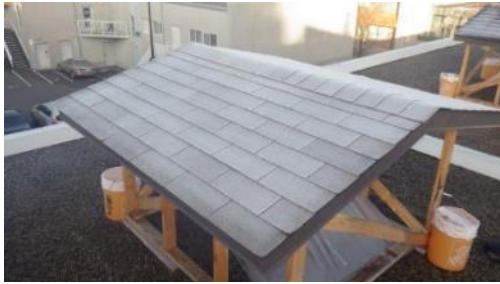
*Figure 2.12 – Frost on exterior of shingles during morning of January 2, 2013*

Night sky cooling and subsequent condensation and frost formation was confirmed visually at various times during the study and an example of typical observations made on January 2, 2013 are provided in Figure 2.12 to Figure 2.15.

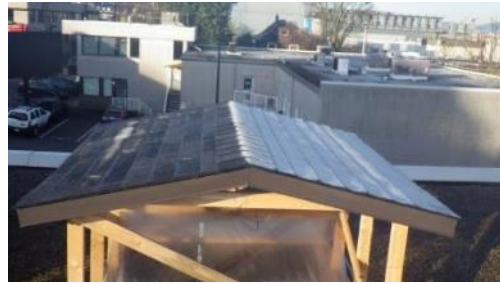
*Figure 2.13 – Frost on exterior of shingles on North orientation but not on South orientation showing the impact of rising sun during morning of January 2, 2013*

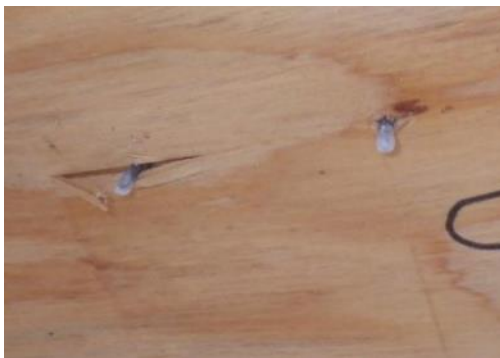
*Figure 2.14 – Frost on nail heads of South facing roof slope on morning of January 2, 2013*

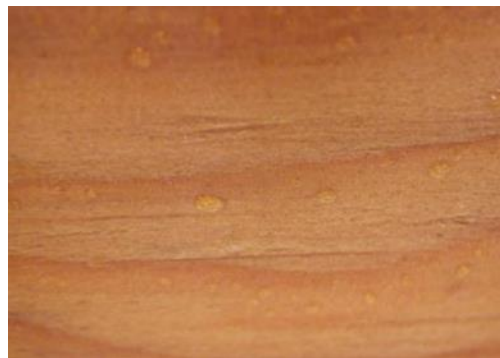
*Figure 2.15 – Condensation on underside of plywood sheathing on morning of January 2, 2013. Note that surface condensation at this time is only visible on certain areas of the plywood and was affected by wood grain.*

Interestingly condensation was mostly visible on areas of the plywood made of heartwood. This is likely because these areas are denser, and potentially include more water repellent extractives; consequently, the surface condensation absorbs less quickly in these areas than it does in the sapwood areas. Two photos further illustrating this effect are provided in Figure 2.16 and Figure 2.17 from October 3, 2013.

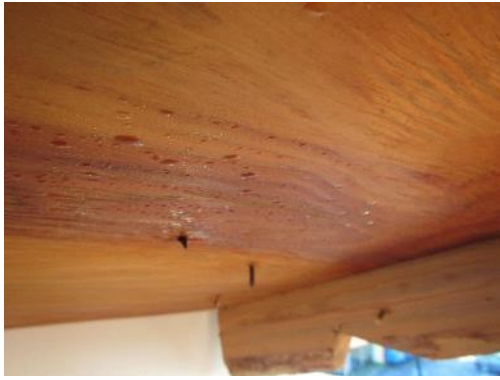
Figure 2.16 - Condensation on the underside of the roof sheathing on October 3, 2013 showing a location where it has been absorbed by the sapwood but has not been absorbed by the heartwood.

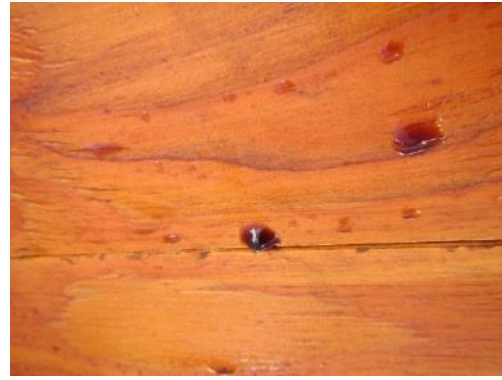
Figure 2.17 - Condensation on the underside of the roof sheathing on October 3, 2013 showing a location where extractives from the wood sheathing are visibly noticeable in the condensation droplets

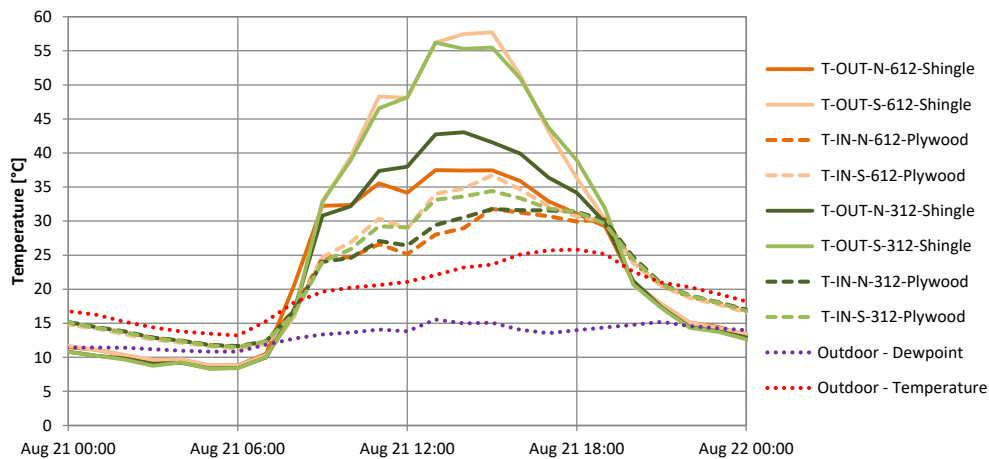
Figure 2.22 – Exterior Shingle and Interior Plywood Surface Temperatures compared to Outdoor Conditions, August 21, 2013

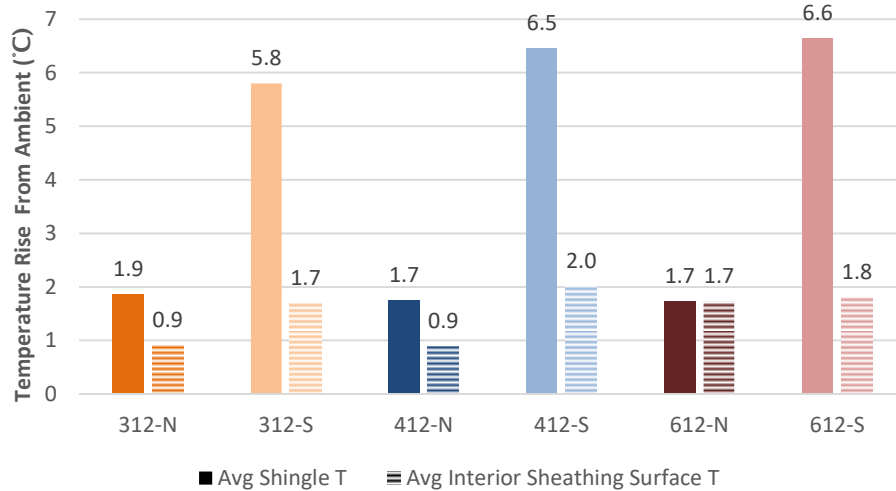
*Figure 2.23 – Average Shingle and Sheathing Temperature Rise Above Ambient for Winter 2013/2014.*

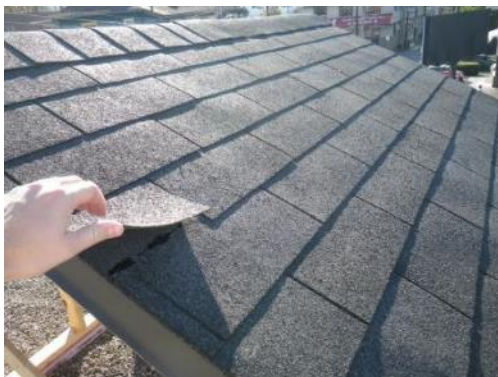
*Figure 2.24 – Poor self-sealing at majority of shingle tabs on North slope observed for several months after installation.*

The increased surface temperatures measured on the South roof orientations also resulted in better self-sealing of the shingle laps as is shown in Figure 2.24 and Figure 2.25. This improved sealing may potentially reduce ingress of water through the shingles as well as the potential for storage of water between the shingle layers.

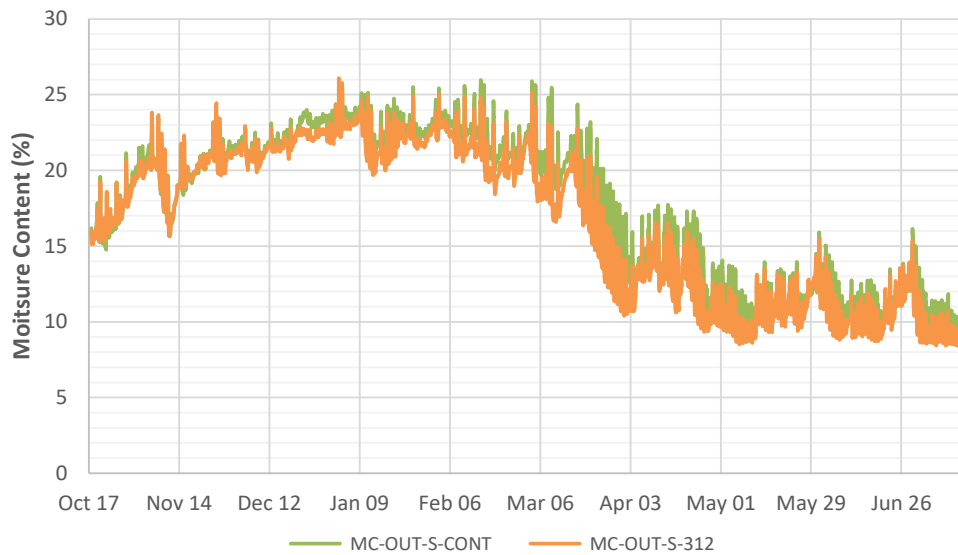
*Figure 2.26 – Moisture Content of Outer 1/8" of Sheathing for Impermeable (CONT) and Permeable (312) Underlayment, South Elevation*

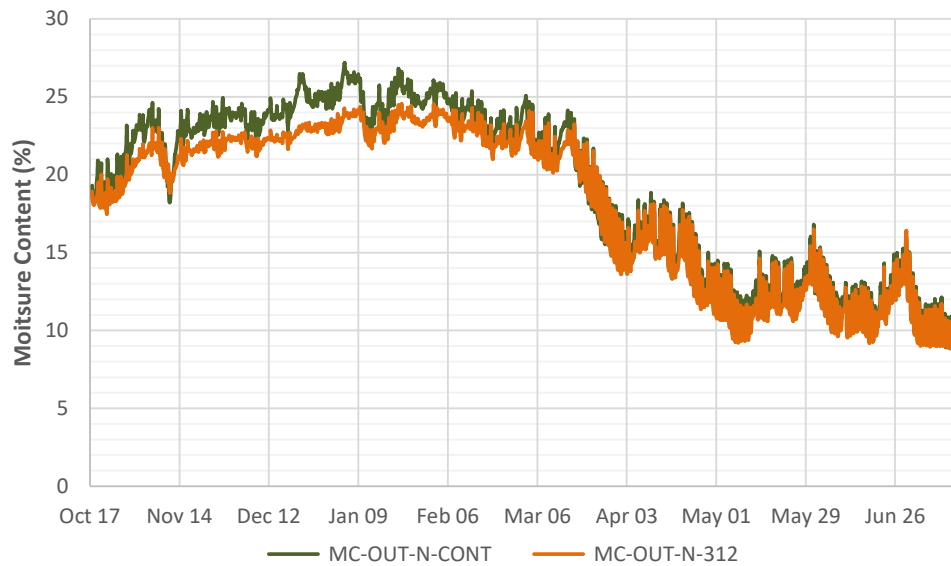
*Figure 2.27 – Moisture Content of Outer 1/8" of Sheathing for Impermeable (CONT) and Permeable (312) Underlayment, North Elevation*

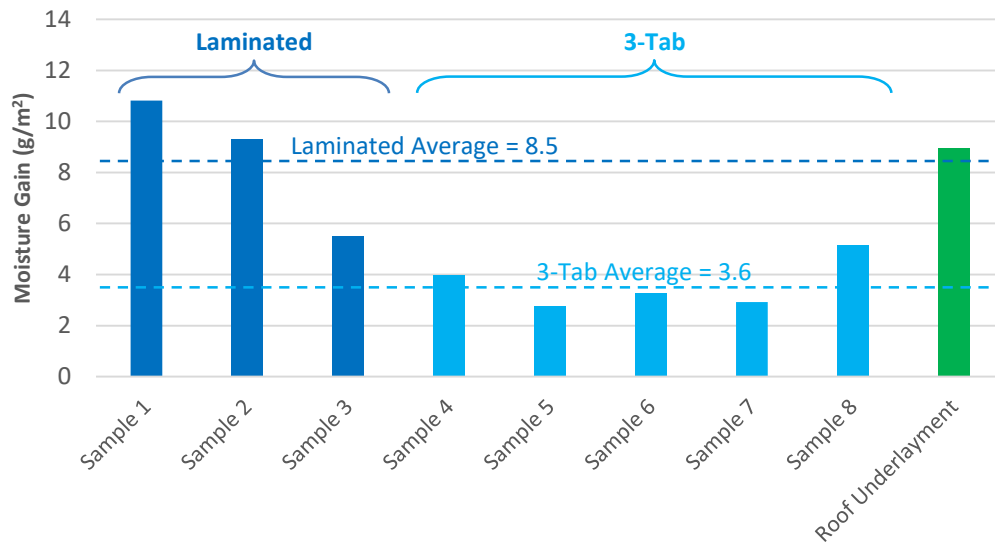
Figure 2.28– Moisture Uptake for 8 Shingle Products and Roof Underlayment

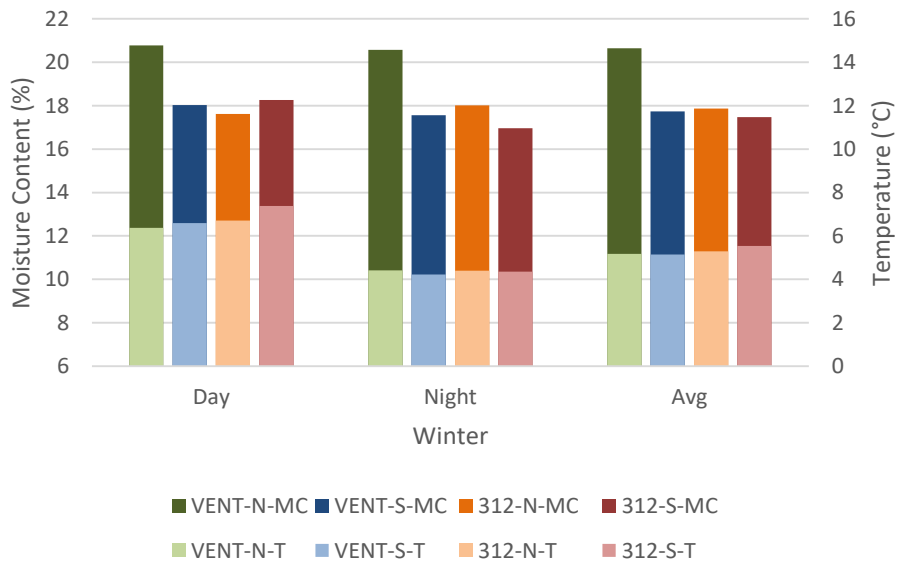
*Figure 3.10– Winter (November 1, 2013 to January 31, 2014) Diurnal Moisture Content (SURF) and Temperature Averages for North and South Oriented Vented and Conventional Roof Assemblies*

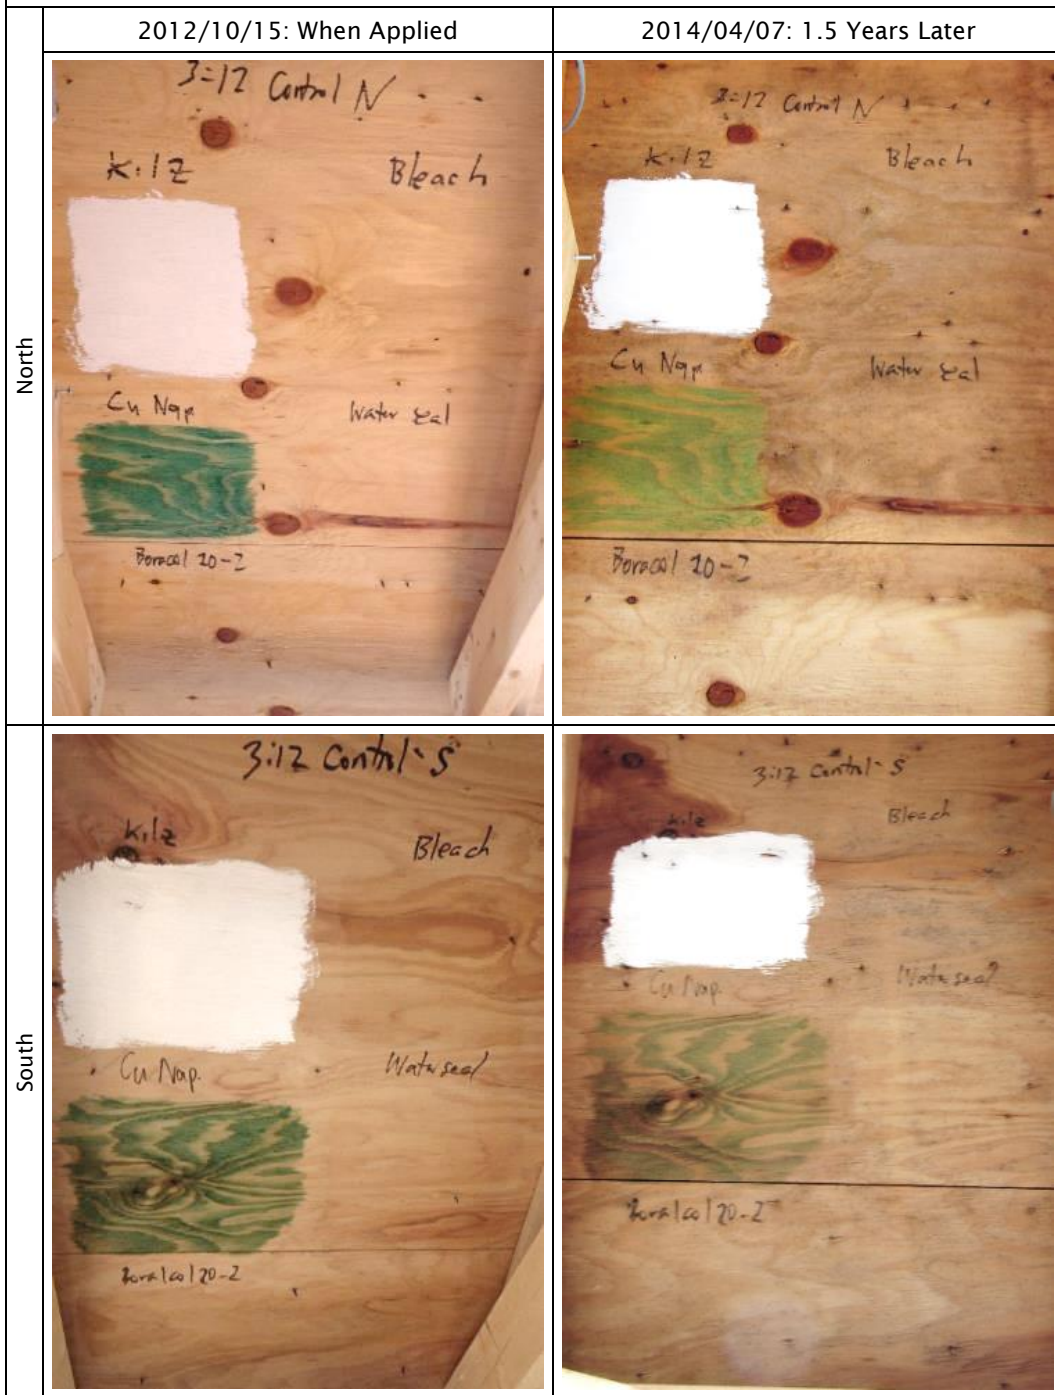
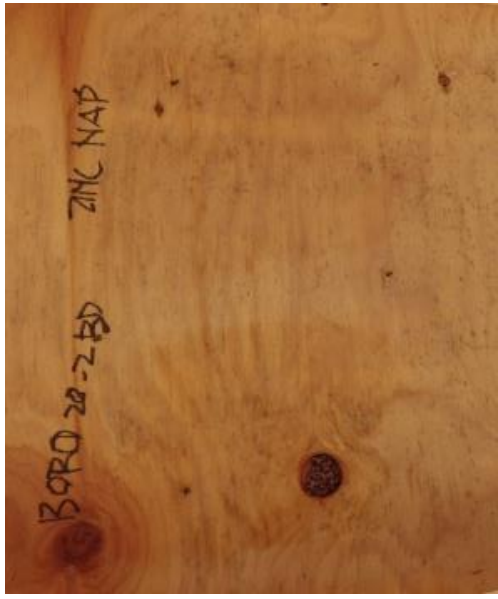
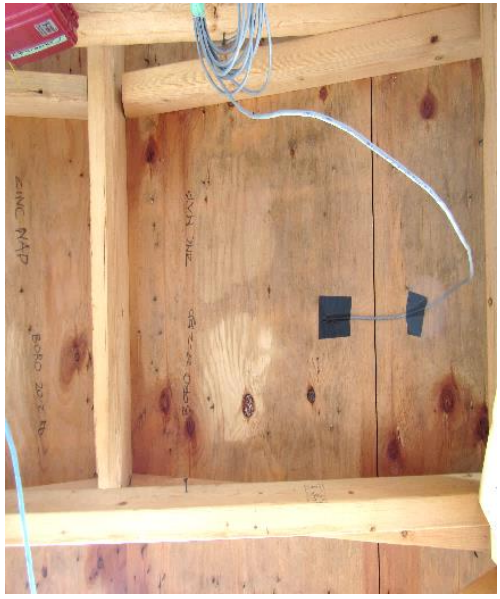
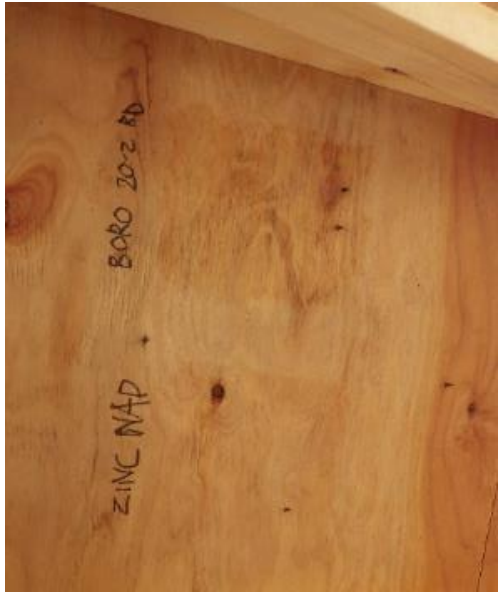
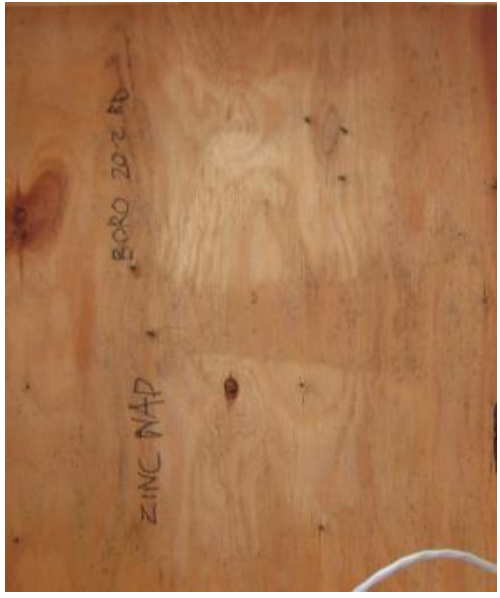
SURFACE TREATMENT VISUAL COMPARISON - CONTROL ROOF

2013/04/11: When Applied (After first Winter)	2014/04/07: 1 Year Later
North

To summarize the efficacy of the surface treatments, a visual rating system was developed and applied to each roof hut orientation. The results from the initial assessment after the first 12 to 18 months (based on product application, see above) are shown in Table 3.3 below

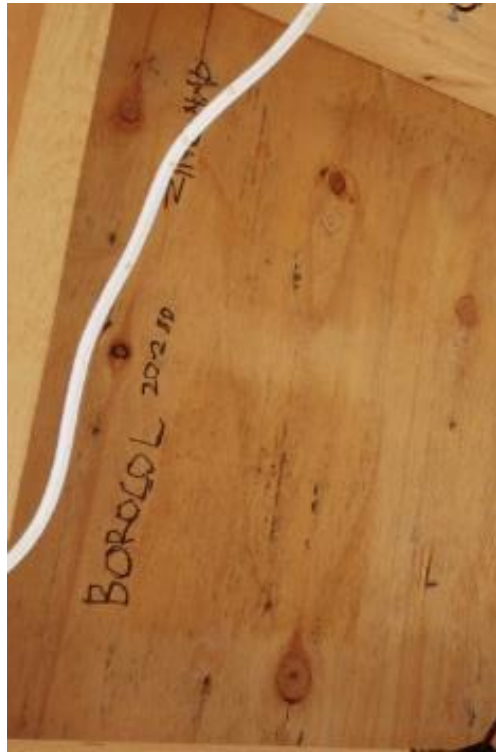
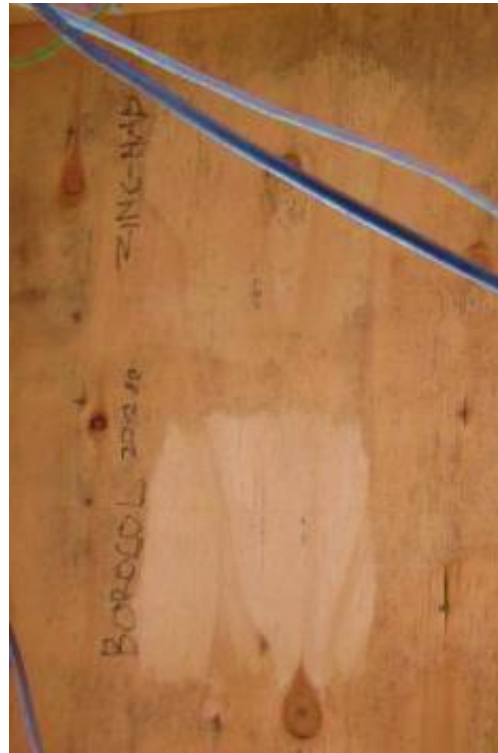
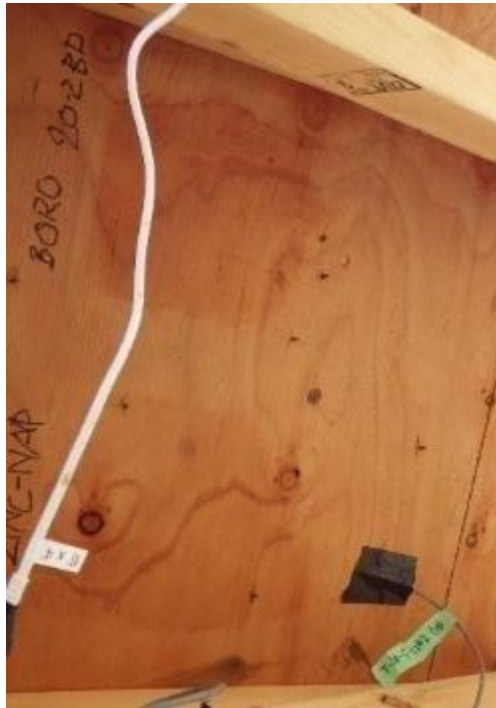
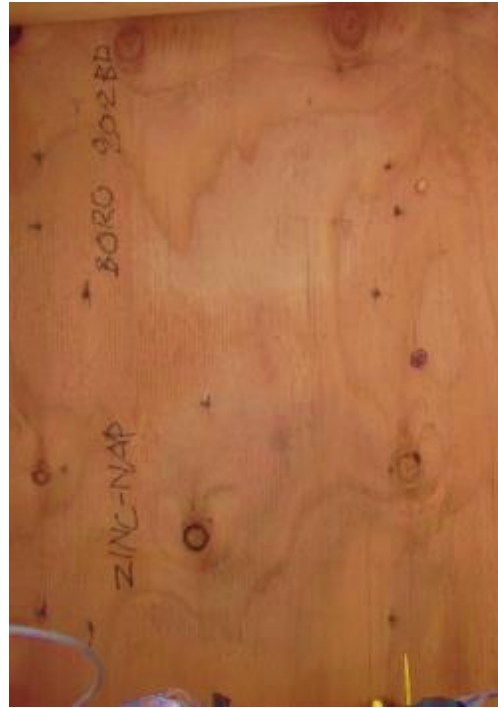
SURFACE TREATMENT VISUAL COMPARISON - 3:12 ROOF

2014/04/07: 1 Year Later
