# Asphalt Shingle Sloped Roofing Research Study

Phase 1

This report was prepared by RDH Building Science Inc. for BC Housing and the Roofing Contractors Association of BC. We gratefully acknowledge their support as this study proceeded.

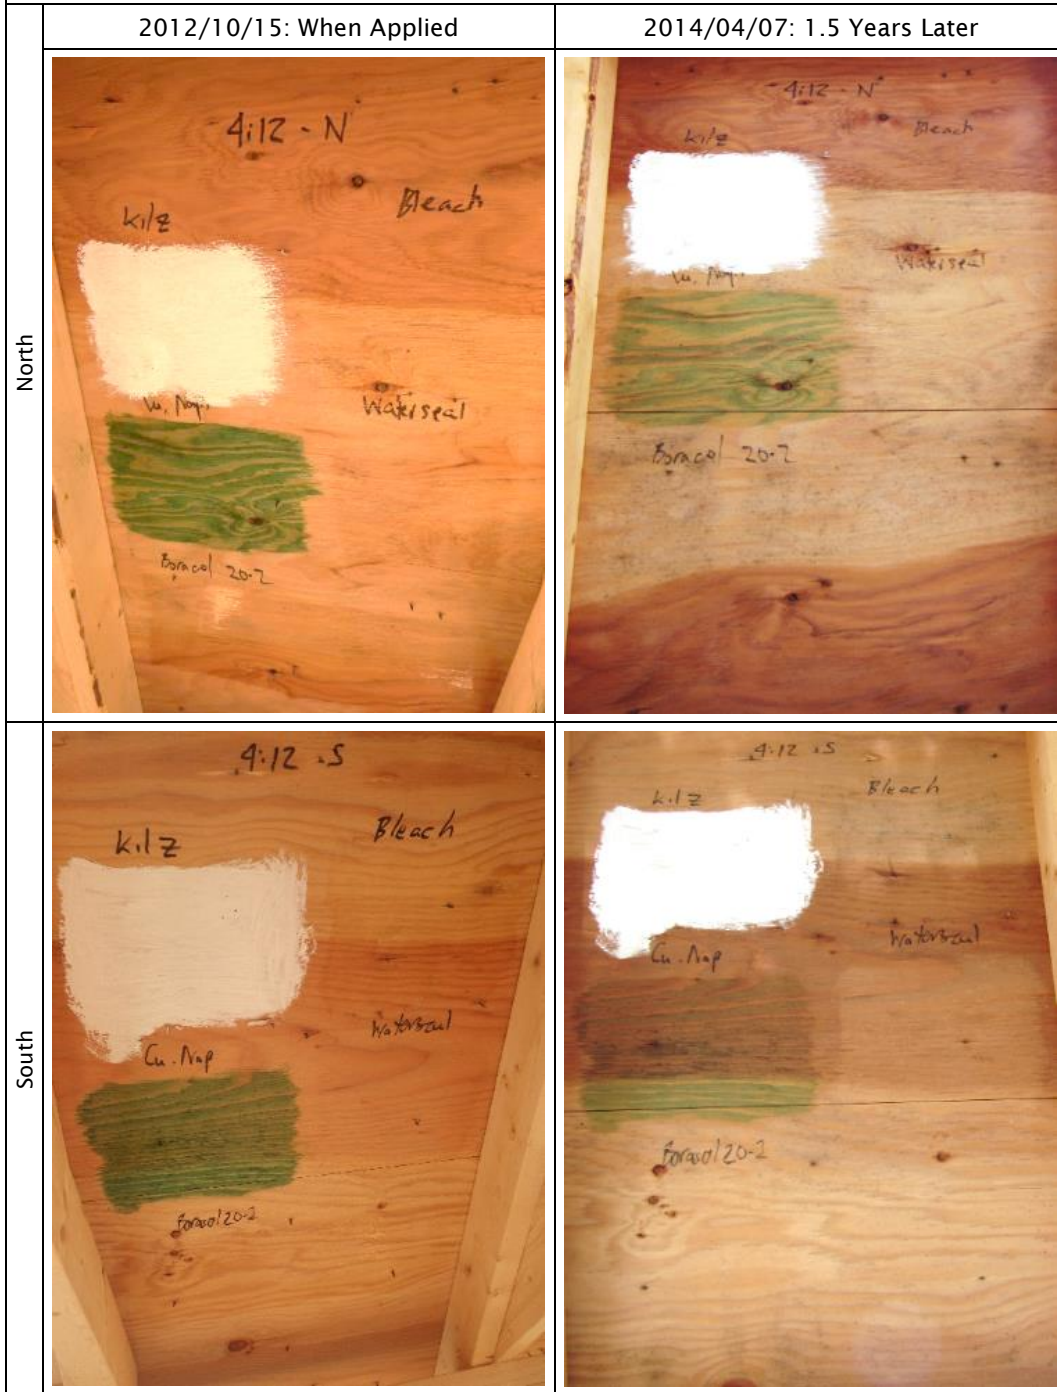
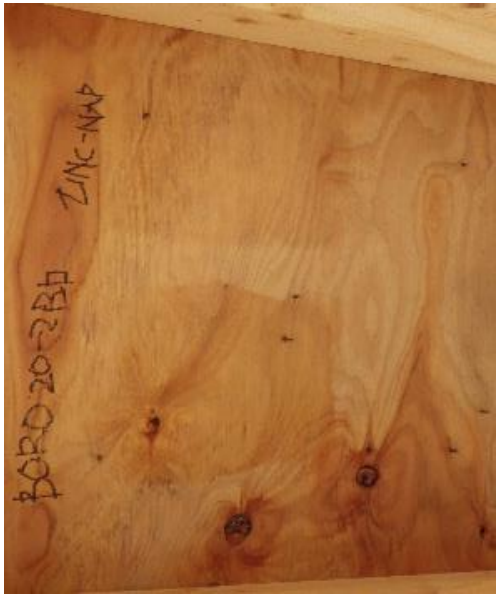
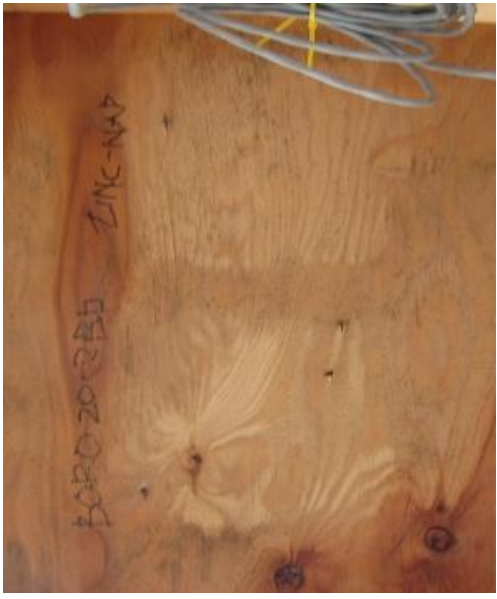
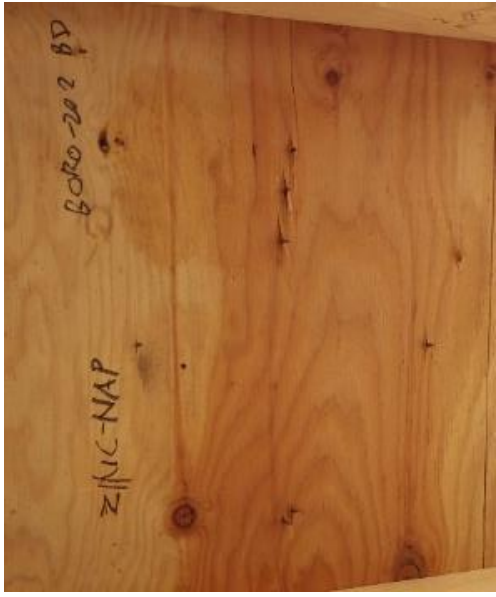
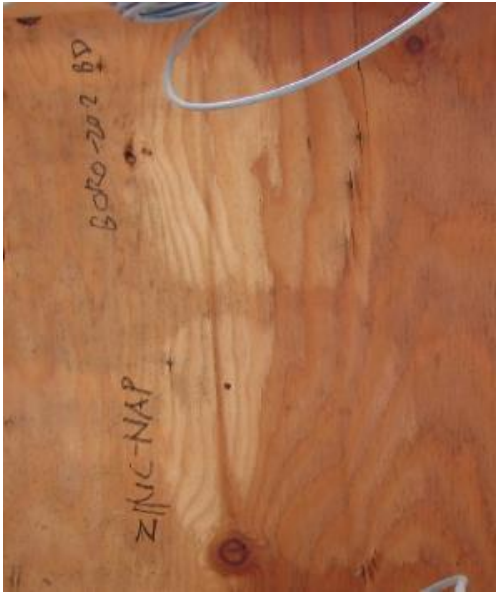
SURFACE TREATMENT VISUAL COMPARISON - 4:12 ROOF

2013/04/11: When Applied (After first Winter)	2014/04/07: 1 Year Later
North

To summarize the efficacy of the surface treatments, a visual rating system was developed and applied to each roof hut orientation. The results from the initial assessment after the first 12 to 18 months (based on product application, see above) are shown in Table 3.3 below

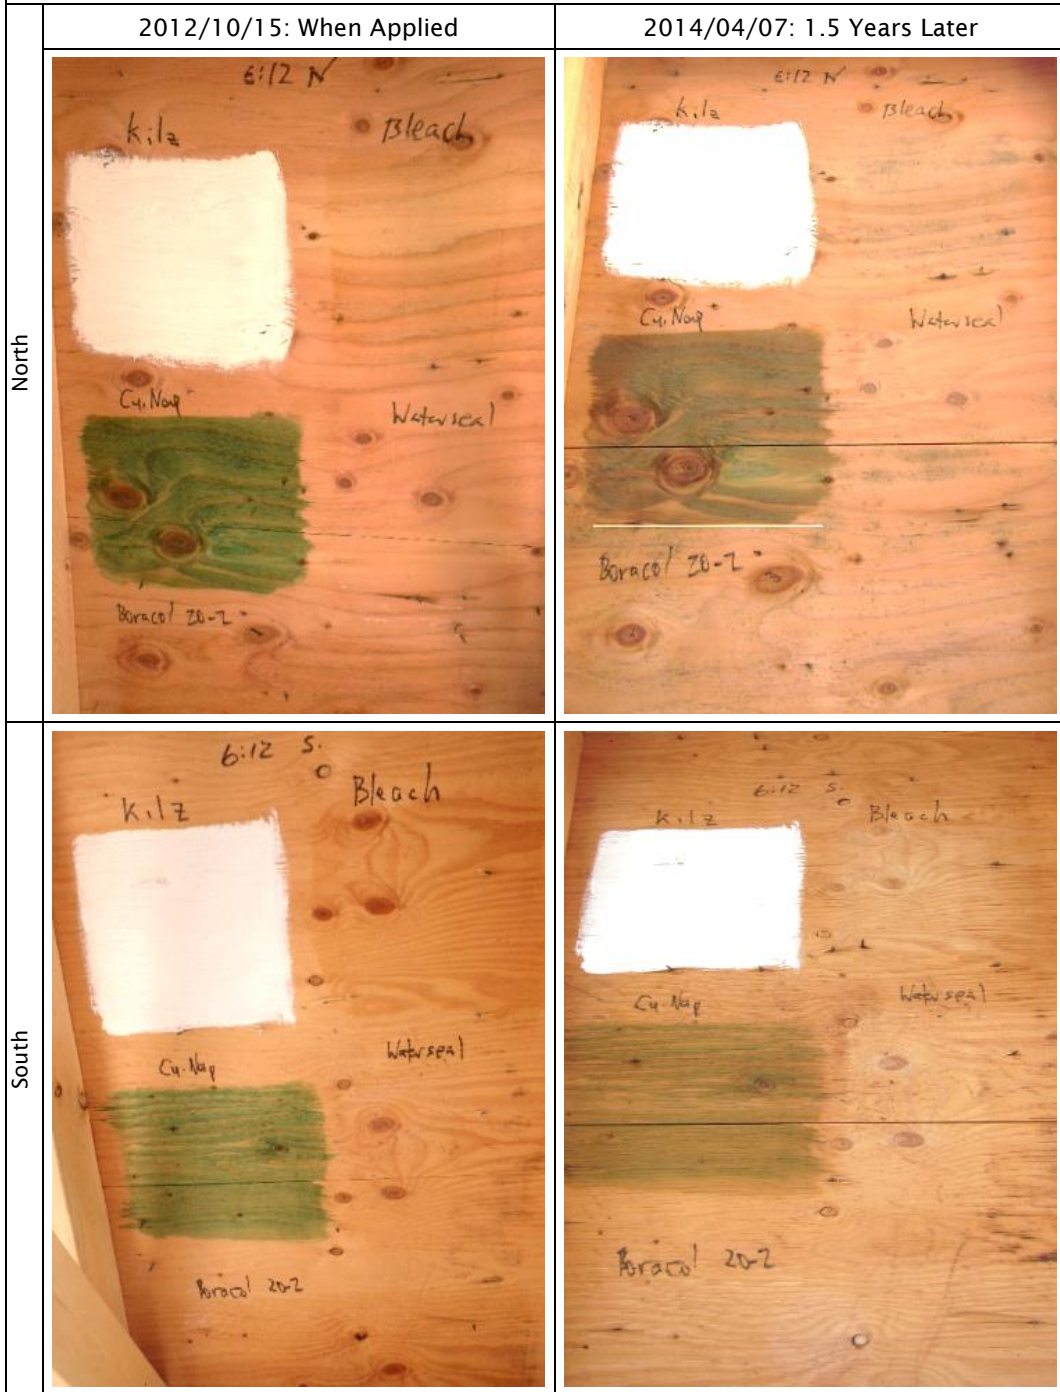
SURFACE TREATMENT VISUAL COMPARISON - 6:12 ROOF

6:12 ROOF APPLICATION ROUND 1

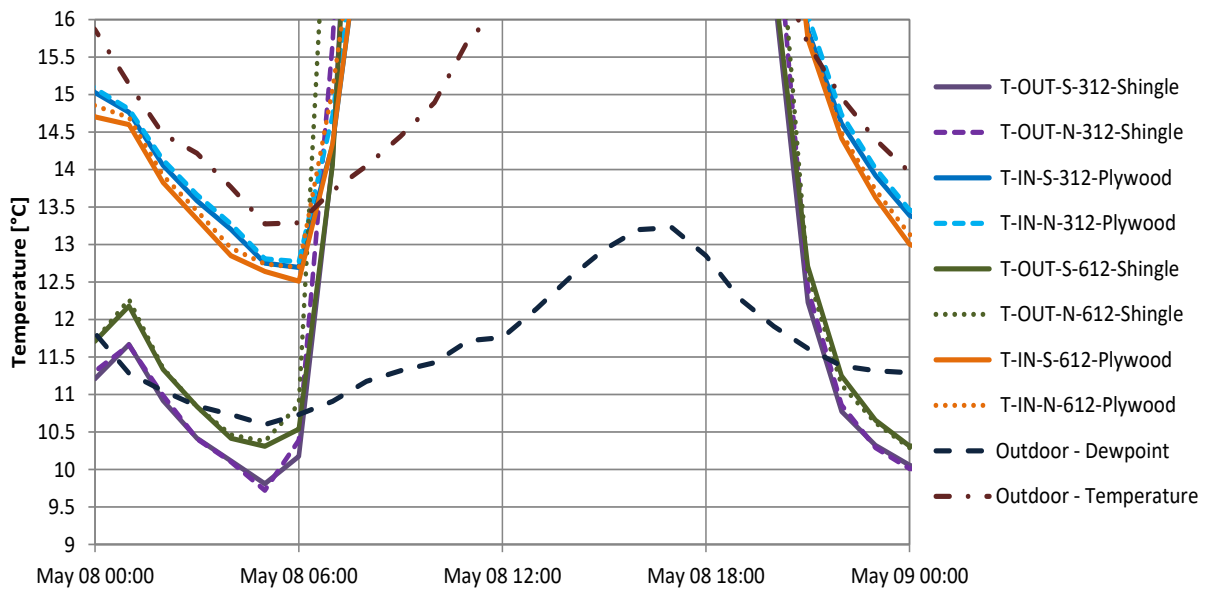
Figure 33 – Shingle and Plywood Temperatures, 3:12 and 6:12 Roofs, both North and South, including Outdoor Dew Point and Sensible Temperatures, May 8, 2013, Showing Condensation
