# Indoor Environmental Quality of Social Housing Buildings in British Columbia

# Executive Summary

On behalf of BC Housing, RDH Building Science Inc. conducted a monitoring study to understand the indoor environmental quality (IEQ) of existing multi-unit social housing buildings in the Metro Vancouver area. The study identified trends in monitored temperature, humidity, and carbon dioxide (CO<sub>2</sub>) concentrations as well as analyzed the IEQ impact of building retrofits and upgrades.

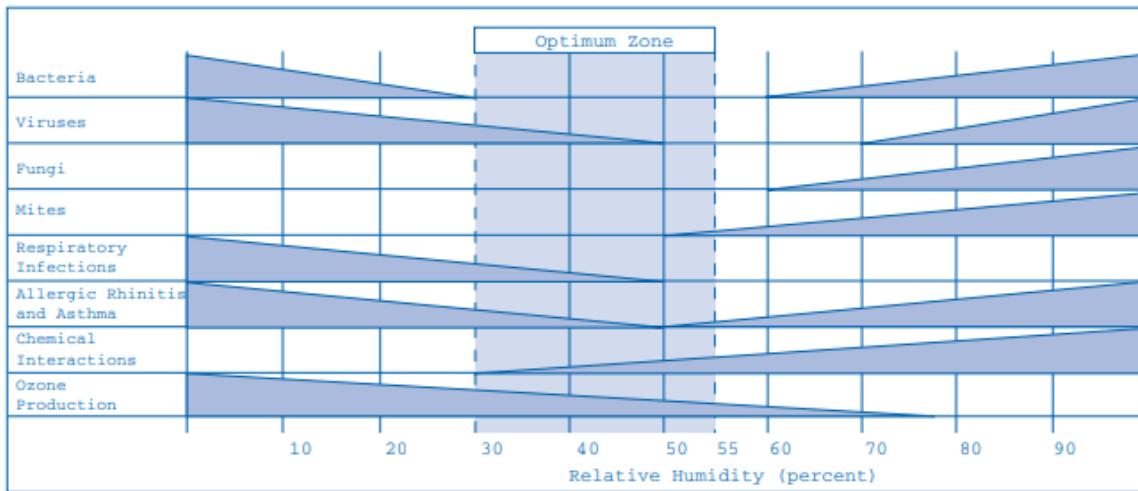
Figure 1.1 – Health range of indoor RH according to Health Canada.

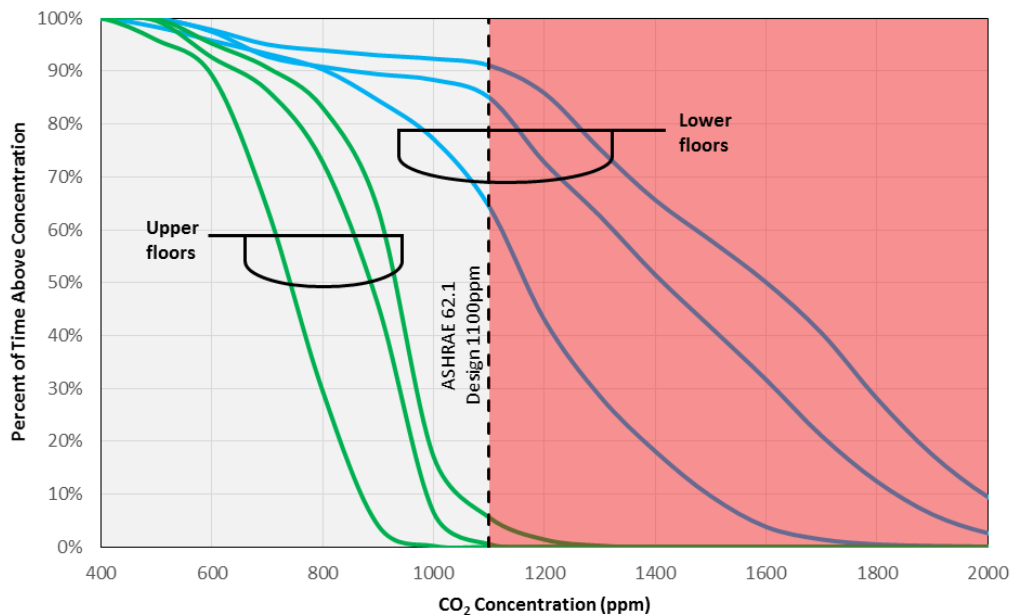
Figure 1.3 – Fraction of time the average suite CO<sub>2</sub> level is above a given concentration in The Belmont Building. Each line represents a separate floor in the building.

In addition to elevated CO<sub>2</sub> concentrations, a long-term monitoring study of a 13-storey multi-unit residential building (The Belmont) performed by RDH Building Science Inc. (RDH), and funded by an industry consortium including BC Hydro, BC Housing, FortisBC and others, showed that CO<sub>2</sub> concentrations in multi-unit residential buildings varied based on suite location within the building.<sup>21</sup> Figure 1.3 shows the fraction of time the average concentration in suites on six different floors of a high-rise multi-unit residential building is above a specified threshold. CO<sub>2</sub> concentrations in suites on the upper floors were (top 25% of the building) generally below the design threshold of 1,100 ppm, whereas concentrations in suites on the lower floors (lower 25% of the building) were found to exceed this concentration more than 65% of the time. What this study and others have shown is that the in-service CO<sub>2</sub> concentration of a building, even one designed to ASHRAE standards, is generally unknown. IEQ and the importance of effective ventilation are garnering increased interest within the building industry and the public. This interest has identified a need for further monitoring studies aimed at establishing a baseline for the existing IEQ within our buildings and to subsequently measure the potential impacts

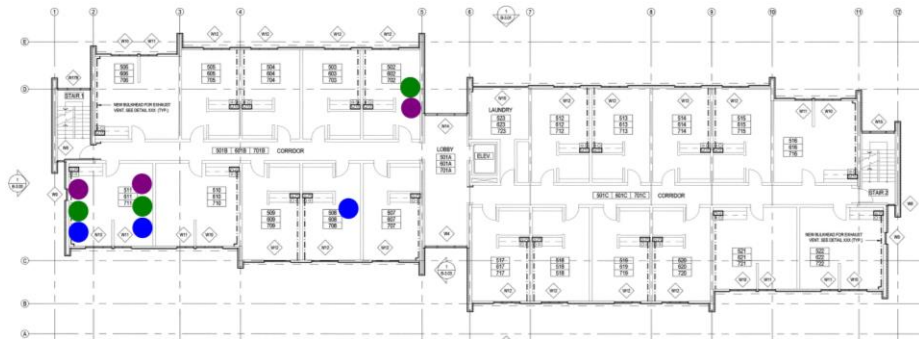
*Figure 3.3 – Location of sensor installations at Building C*

Six suites, one SRO and a one-bedroom unit on each of levels 3, 5, and 7, agreed to participate in the study. One CO<sub>2</sub> sensor was installed in each of the three SRO units and two sensors in each of the one-bedroom units along with an additional sensor in the 5<sup>th</sup> floor corridor to capture common air background conditions. The sensor locations within the building are shown on the floor plan in *Figure 3.3*. The suites layout is identical on level 3 to level 7.

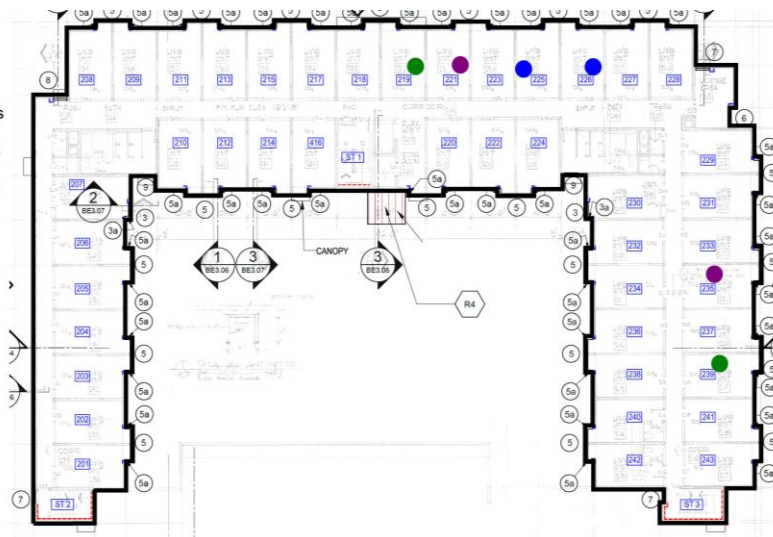
Figure 3.5 – Location of sensor installations at Building E

Building E is a four-storey concrete low-rise apartment. The building consists of two wings (West and East) off a central corridor (North). All suites in the building are SRO containing a living/sleeping area and a washroom. The building ventilation is provided by a rooftop make-up air unit that supplies in to the North and East wings and exhausts from the West wing. The suites do not have direct ventilation but are equipped with intermittent exhaust fans in the washroom. The building renewal included replacement of the windows in suites and common areas, replacement of exterior doors, sealing of bricks and a partial cladding replacement. One CO<sub>2</sub> sensor was installed in each of the six suites. The sensor locations within the building are shown on the floor plan in Figure 3.5.

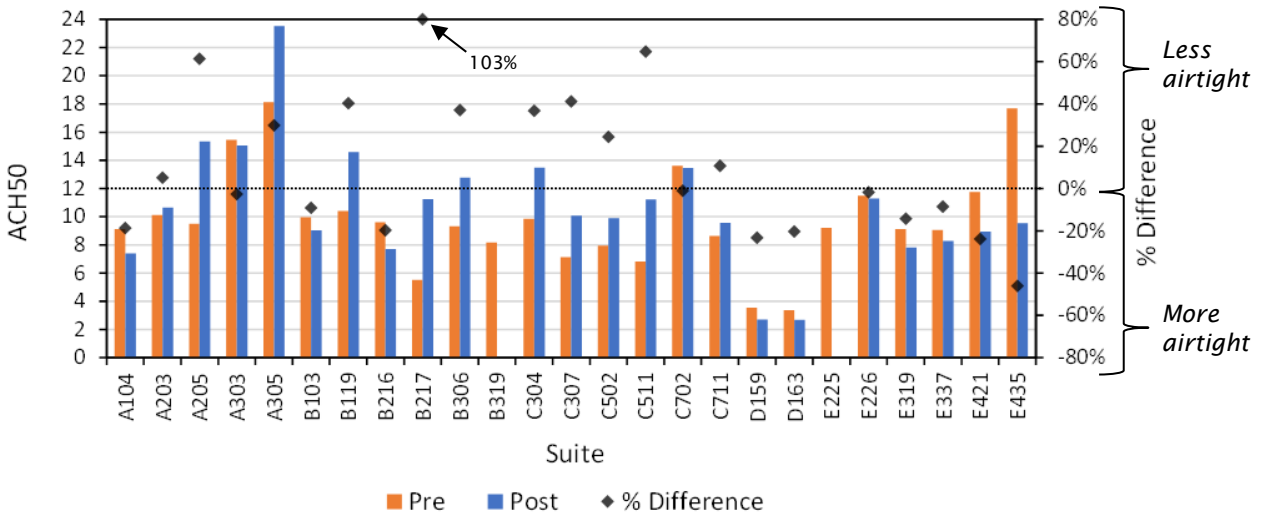
Figure 4.4 – Pre- and post-retrofit average airtightness test (ACH50) and percent difference.

*Figure 4.4* displays the average pre- and post-retrofit airtightness and percent difference for each suite. The measurements show that post-retrofit airtightness slightly improved for some suites and significantly worsened for others. For the units that became more airtight, the difference in pre- and post-airtightness was generally between 5% and 20%.

For the units that became less airtight, the values varied significantly between 5% and 60%, with one suite measuring over 100%. The inconsistency in airtightness differences before and after the retrofits may be the result of a lack of attention to airtightness and air sealing during the implementation of the retrofit measures. For example, if new windows are installed to replace older 'leakier' windows, the overall air leakage measurement taken after the window replacement can still be greater if the site-installed air seal between the window frame and the wall rough opening is not continuous.

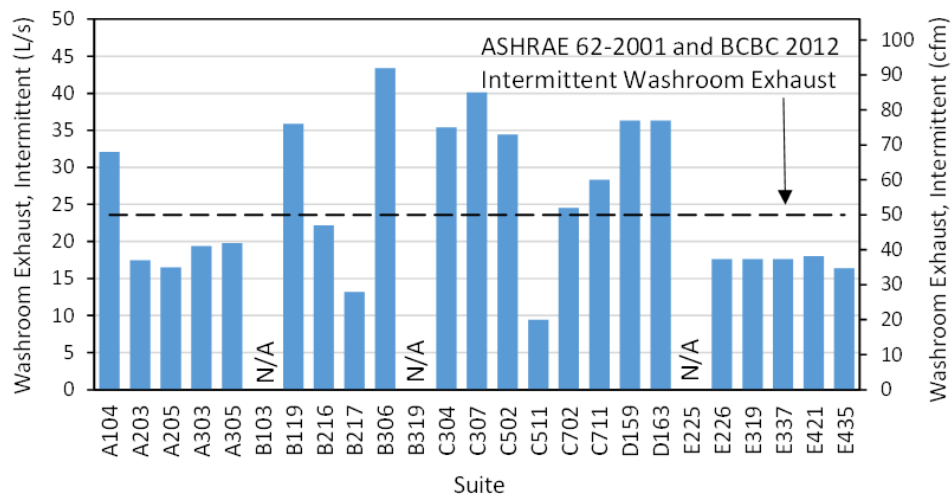
Figure 4.6 – Post-retrofit washroom exhaust airflow rates (N/A indicates that no flow measurement was taken)

Rather than direct supply of outdoor air for ventilation, the suites in this study relied on either a combination of natural air infiltration through operable windows and/or the use of intermittent exhaust fans within the space, with make-up air coming from the corridor or other openings in the suite. The airflow rate provided by the intermittent washroom exhaust fans was measured and compared with code minimum values for each unit pre- (Figure 4.5) and post-retrofit (Figure 4.6). The measurements show that prior to the retrofits, most of the washroom exhaust fans provided airflow rates lower than the rates specified in the relevant codes and standards. Flow rates improved for many suites after the retrofits; however, around half of the measured units are still below code minimum rates. Note that four of five buildings underwent fan replacements or upgrades (Buildings A, B, D and E). Interestingly, Building A's exhaust fan flow rates did not improve significantly overall whereas Building C exhaust fan flow rates improved despite no note of fan retrofits.

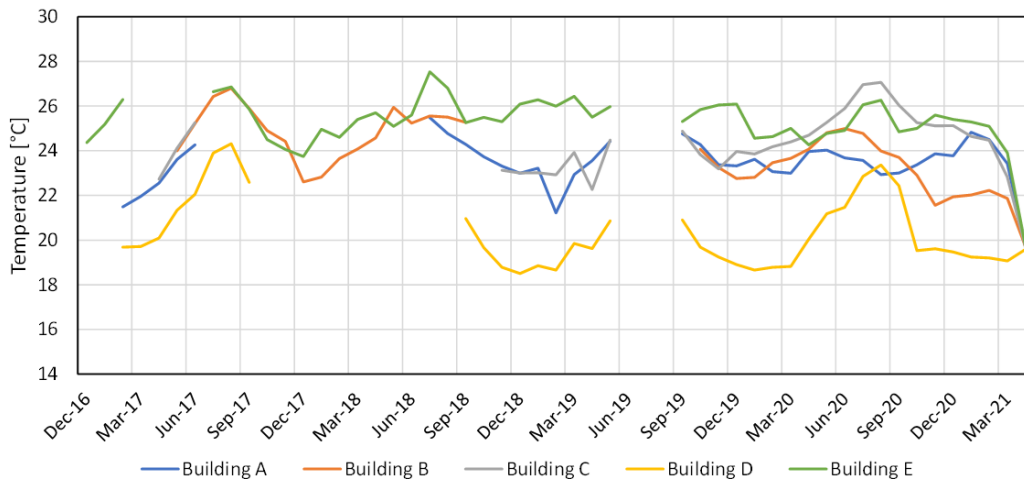
*Figure 4.7 - Monthly average air temperature for each building. Gaps in data are either retrofit periods or missing data.*

Of the five sites, only Building A (semi-detached homes) exhibited comfortable (according to ASHRAE Standard 55) average temperatures year-round. This trend is also apparent in *Figure 4.7* which shows the average monthly temperature for each building. The cooler temperatures measured in Building A are likely a result of greater control via the multiple thermostats and an increase in the number of operable windows allowing for improved cross-ventilation.

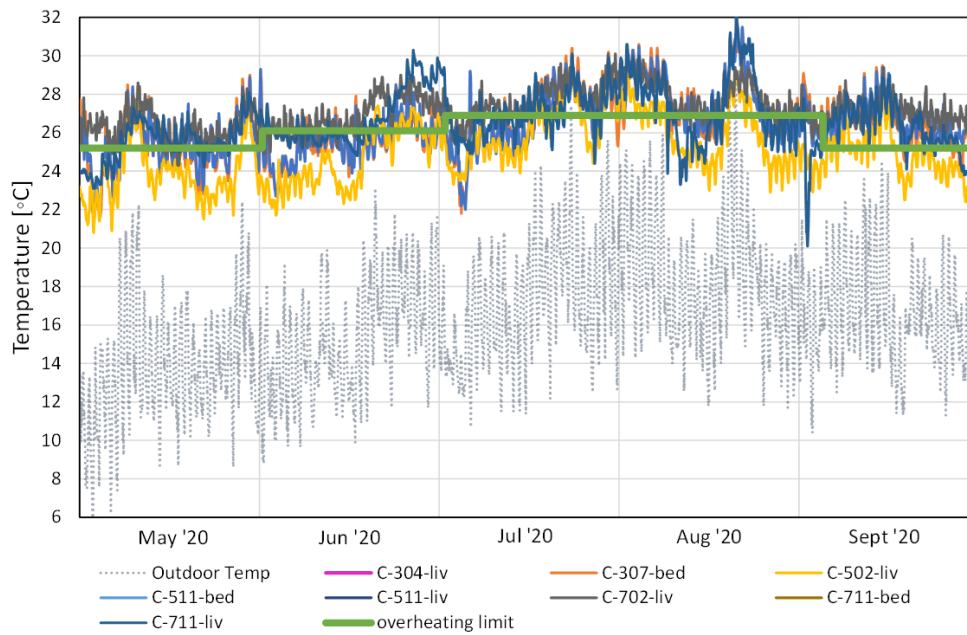
Figure 4.9 – Suite interior air temperature for Building C (2020, post-retrofit) against the summer overheating limit defined by BC Housing Design Guideline and City of Vancouver Energy Modelling Guidelines. Note that the acceptability limit varies by month.

The measured indoor temperatures during summer 2020 for all suites was compared against the overheating limit defined by BC Housing Design Guideline (COV Energy Modelling Guideline – Table 4). *Figure 4.9* and *Figure 4.10* are two examples of this comparison for Building C and Building D, respectively. See *Appendix C* for all overheating analysis plots. The plots show that the interior air temperatures in Building C exceed the overheating limit for a significant portion of the defined summer period. The suites in Building D, by comparison, exceeded the overheating limit far less. *TABLE 4.3* lists all the measured suites and the number of overheating hours. Results suggest that overall, the suites across all buildings exceeded the overheating limit roughly 21% of the summer in 2020.

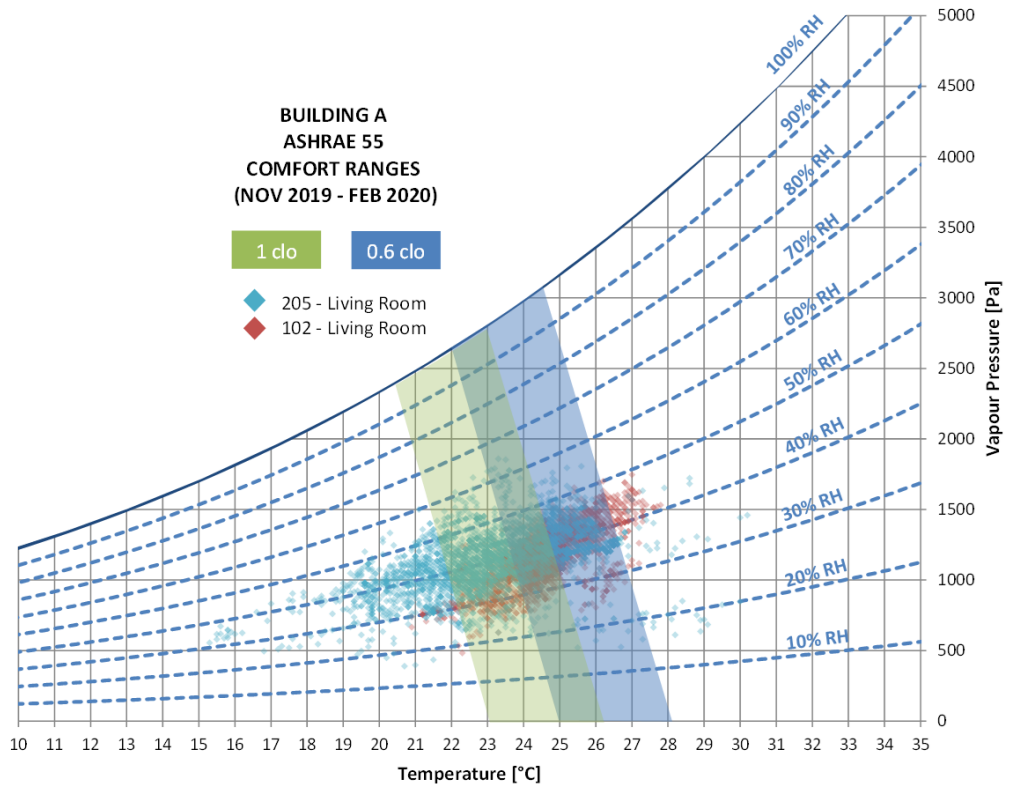
Figure 4.12 - Hourly air temperature measurements of two samples suites from Building A plotted on psychrometric chart (winter)

*Figure 4.11* and *Figure 4.12* plot the air temperature and RH measured in two suites in Building A during summer and winter 2020, respectively. Results show that the conditions in both suites are similar and lie primarily within the ASHRAE comfort range. *Figure 4.13* and *Figure 4.14* plot two sample suites in Building E during summer and winter 2020, respectively. In summer, the bulk of the data lies on the edge of the upper limits of the comfort range, suggesting that the suites are too warm. In winter, suite 421 lies within the upper limit of the comfort range, whereas suite 435 is consistently outside the comfort range. Solar and internal heat gains are likely responsible for the upper points on the plots, whereas open windows in the winter are likely responsible for the lower points. It is important to note that people may in fact be comfortable in these environments despite the conditions laying outside of the ASHRAE Standard 55 comfort range either due to adaptation or changing clothing and activity levels. For this reason, thermal comfort surveys should be considered as a means of verifying these findings.

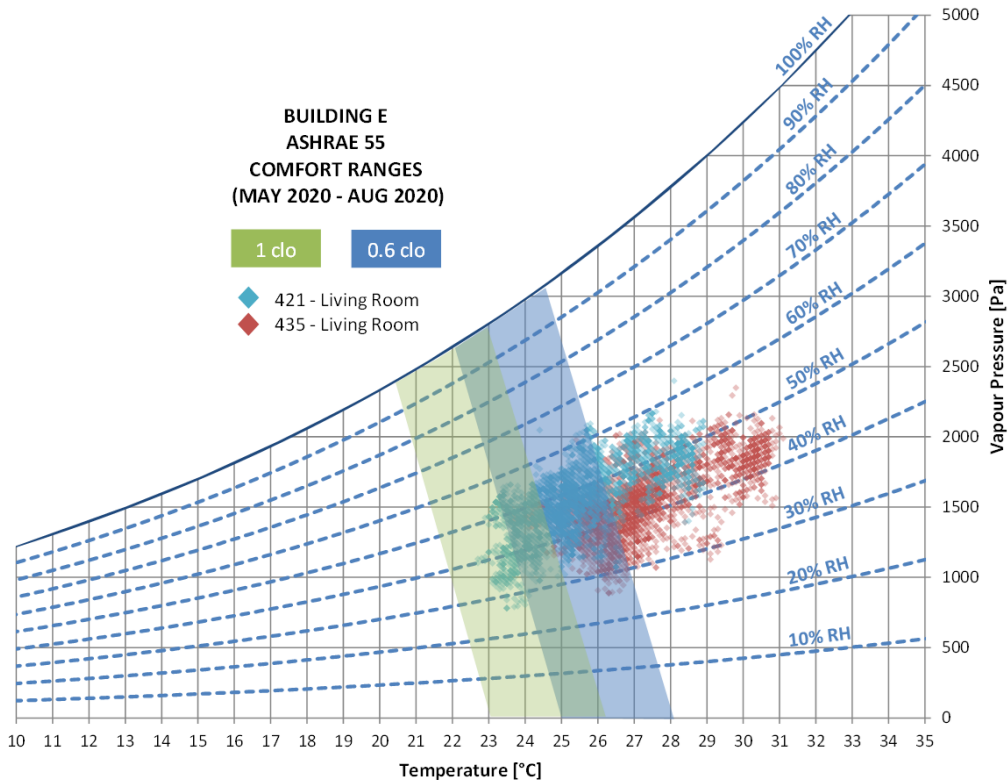
Figure 4.13 – Hourly air temperature measurements of two samples suites Building E plotted on psychrometric chart (summer)

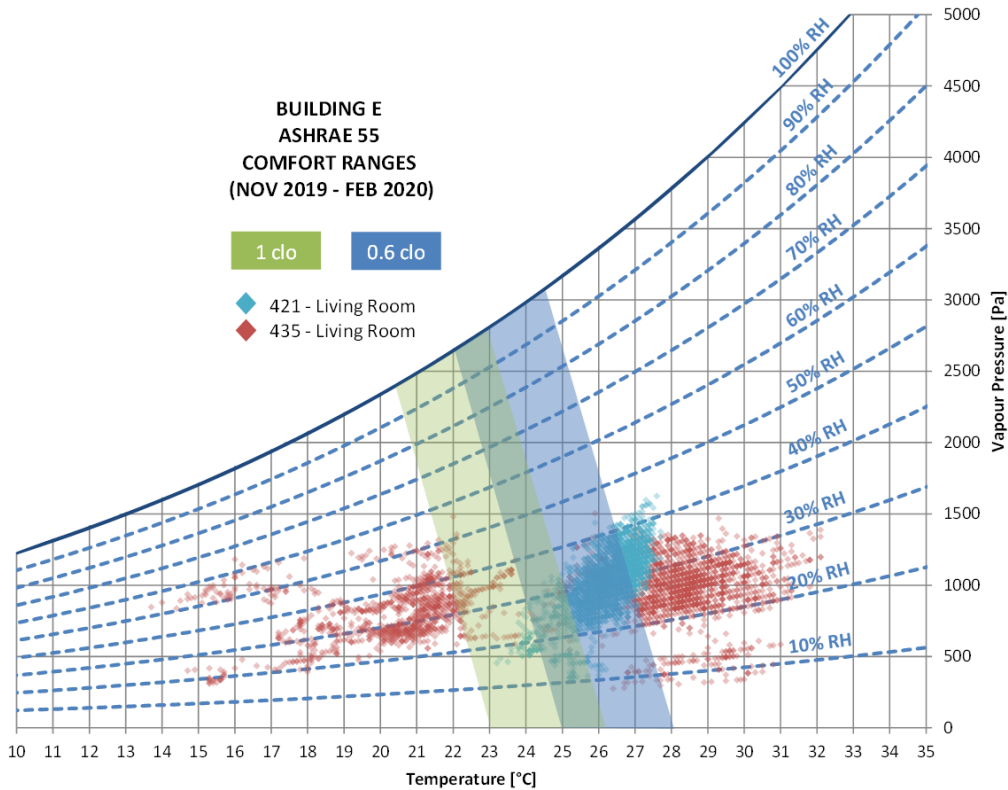
Figure 4.14 – Hourly air temperature measurements of two samples suites from Building E plotted on psychrometric chart (winter)

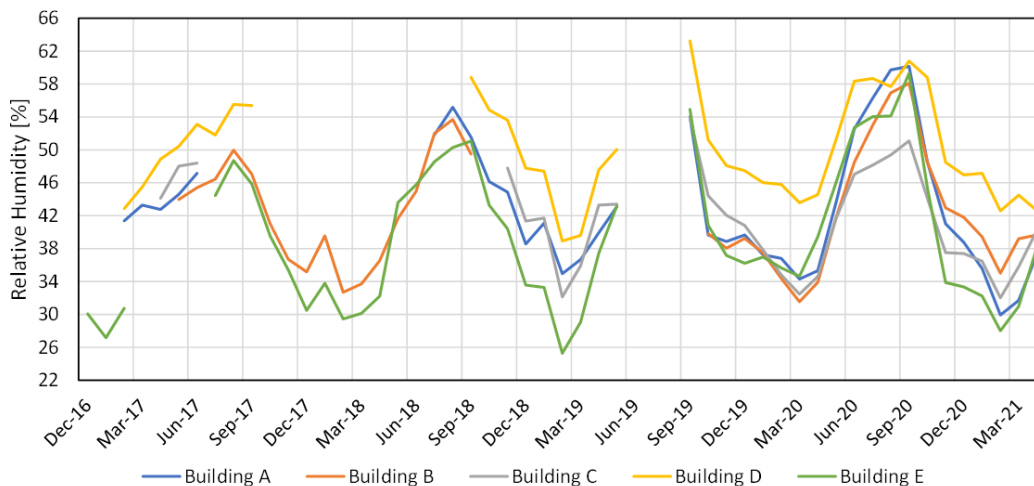
Figure 4.15 - Monthly average RH for each building. Gaps in data are either retrofit periods or missing data.

Figure 4.15 shows the average monthly RH for each building. Results show that RH is generally consistent for all buildings, with the exception of Building D, which experienced higher RH levels for the majority of the monitoring period. The monthly average RH readings are typically within the 30% to 60% design range for comfort. Generally, the reported monthly average RH levels did not reach above 60% (with the exception of a few cases), which indicates that the spaces do not typically experience excessive humidity. However, some of the spaces do show levels that are at the high end of the typical design scale and may be a concern. High RH is a concern in the winter due to potential condensation and is a concern in the summer because of the associated impacts on indoor comfort.

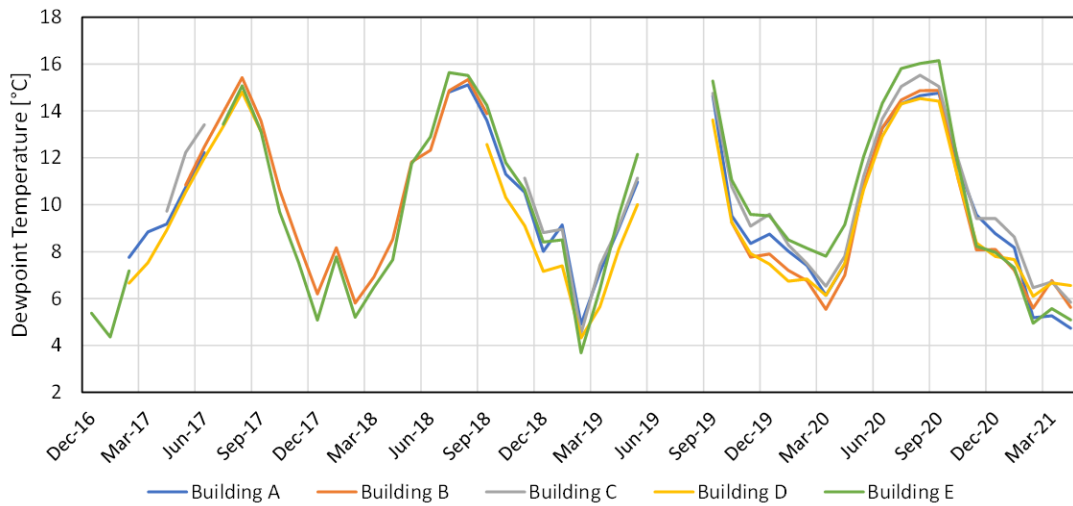
*Figure 4.16 – Monthly average dew point temperature for each building. Gaps in data are either retrofit periods or missing data.*

The average monthly dew point temperature of buildings in the study are shown in *Figure 4.16*. The dew point temperatures show sharp increases and decreases in the summer and winter months, respectively. Higher dew point temperature in the summer months is expected and are generally less of a concern in heating dominated climates.

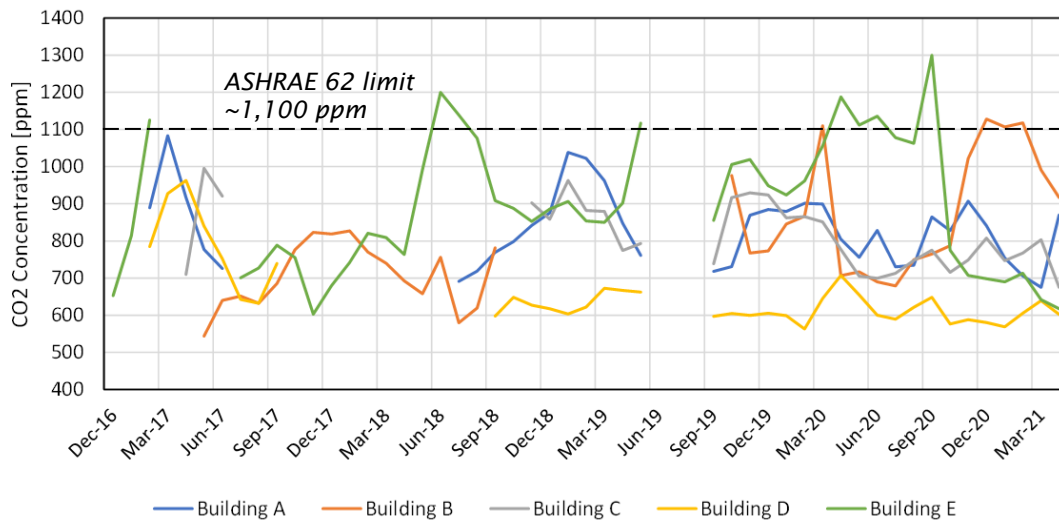
*Figure 4.20 – Monthly average carbon dioxide concentrations for each building. Gaps in data are either retrofit periods or missing data*

*Figure 4.20* shows that the average CO<sub>2</sub> concentration in most suites was in the range of 500 to 1300 ppm, which is generally within normal design conditions. However, most monitored suites experienced CO<sub>2</sub> concentrations in excess of 1,100 ppm for more than 20% of the monitoring period. Examining the hourly data in a sample of the suites showed that the CO<sub>2</sub> concentrations typically increased in the evening and overnight with a decrease the following morning. This finding is generally consistent with standard occupancy patterns, where CO<sub>2</sub> steadily rises when occupants are present in the evening and sleep.

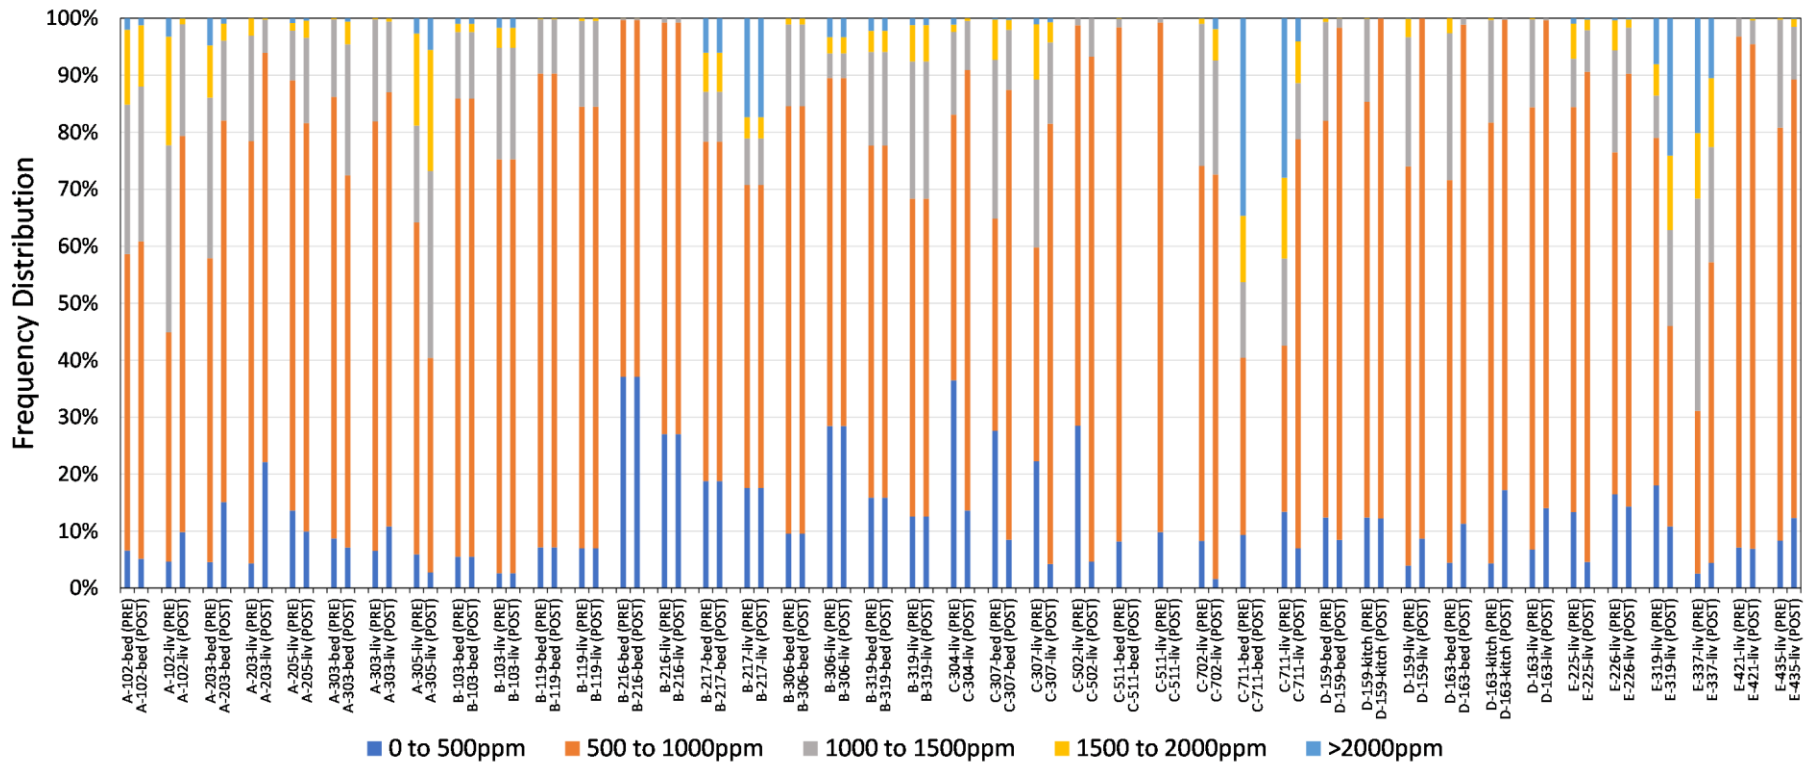
Figure 4.21 – Frequency distribution of CO<sub>2</sub> concentrations (pre- vs. post-retrofit). Blank columns are the result of no measurements taken during the defined analysis period.

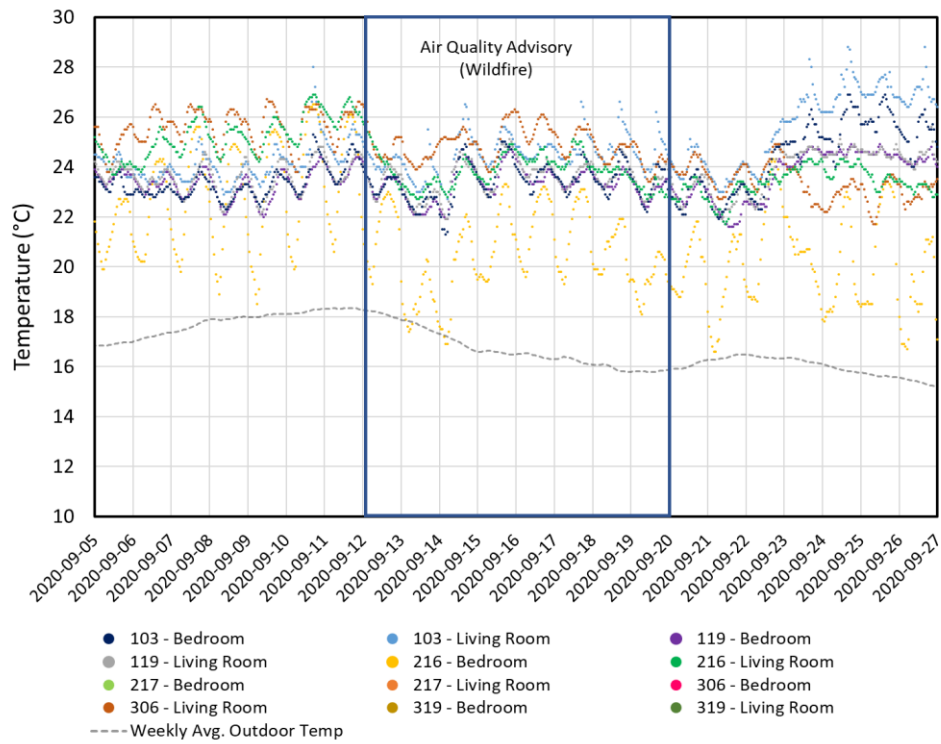
Figure 4.24 – Air temperature measurements during the Metro Vancouver Air Quality Advisory (Building B)

*Figure 4.24* and *Figure 4.25* plot the air temperature and CO<sub>2</sub> concentrations during the September 2020 Metro Vancouver Air Quality Advisory for Building B and Building A, respectively. The plots include data from one week before and one week after the advisory for comparative purposes. The results show that the temperature in Building B did not significantly change as a result of the advisory; however, the CO<sub>2</sub> concentrations in Building A appear to have increased suddenly at the beginning of that period. This agrees with the public health recommendations to stay indoors with windows and doors closed. For similar plots of other measured buildings, see *Appendix A* and *Appendix F*.

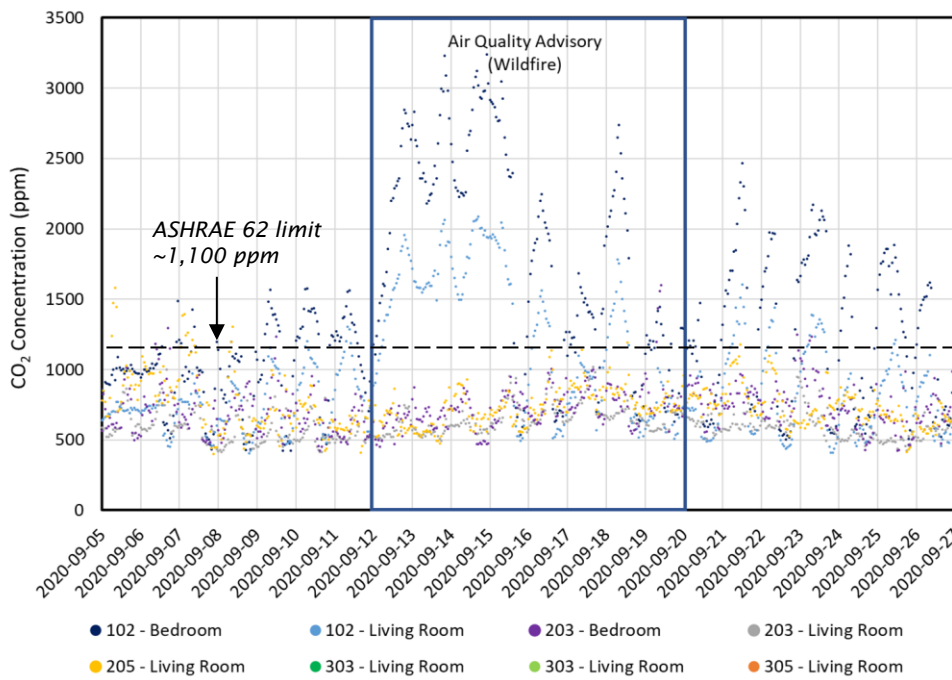
Figure 4.25 – CO<sub>2</sub> concentration measurements during the Metro Vancouver Air Quality Advisory (Building A)

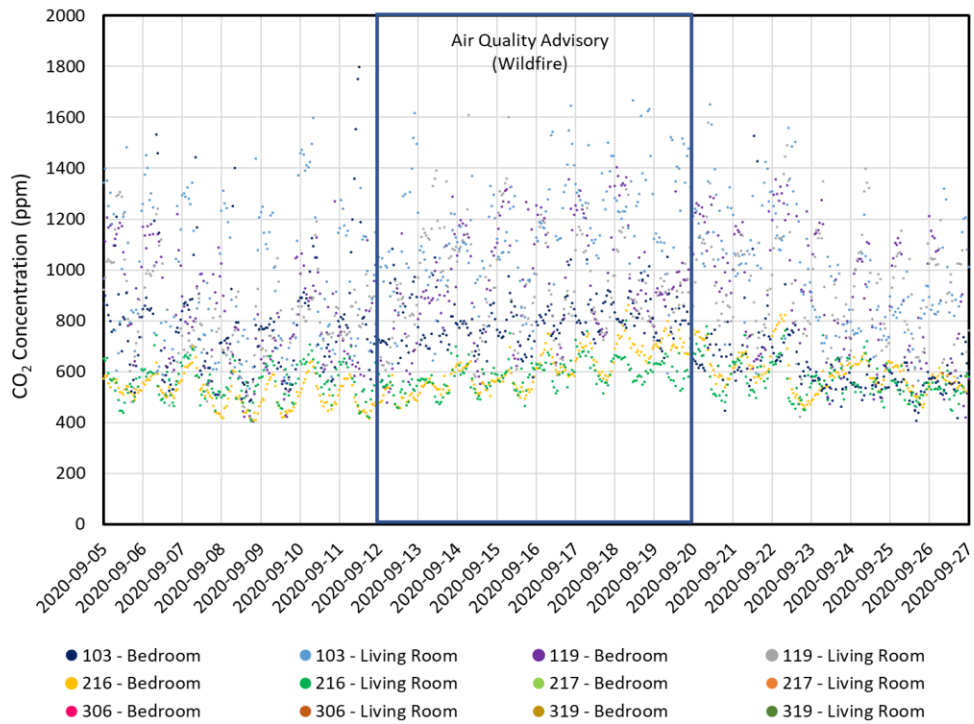
Appendix A.8 – CO<sub>2</sub> concentration one week before, during and after the 2020 wildfire air quality advisory (Building B)

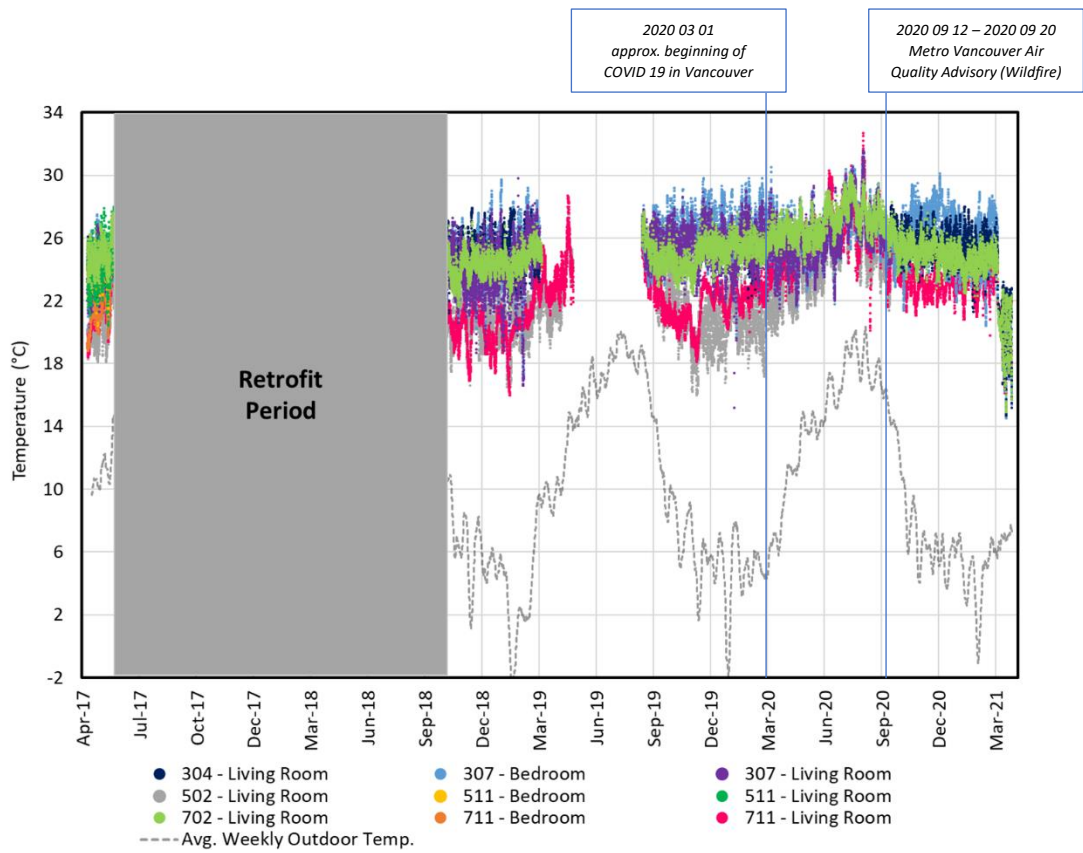
Appendix A.9 – Air temperature measurements throughout monitoring period (Building C)

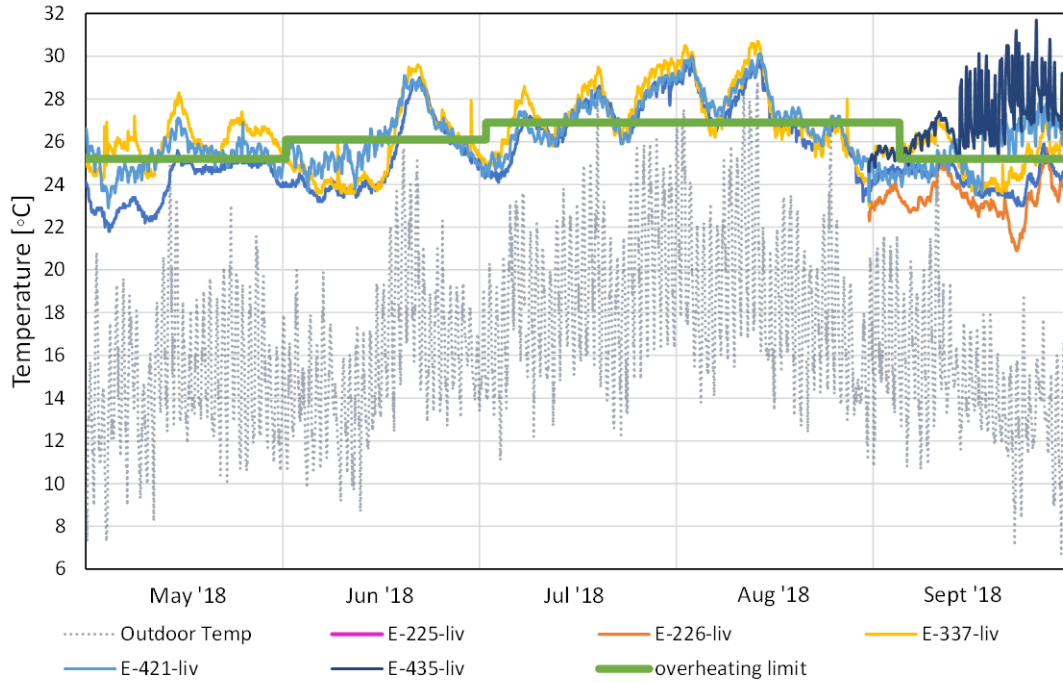
Appendix C.1 – Suite interior air temperature for Building E (2018, post-retrofit) against the summer overheating limit defined by BC Housing Design Guideline and City of Vancouver Energy Modelling Guidelines.

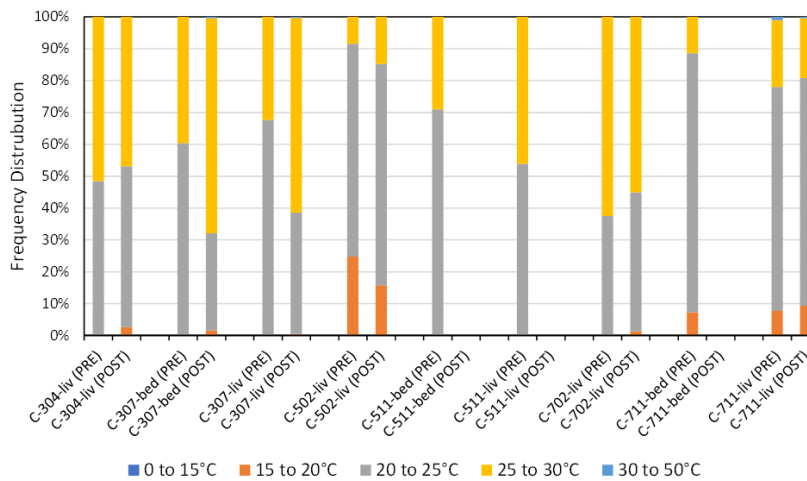
Appendix E.3 – Pre/post-retrofit air temperature frequency distribution for Building C

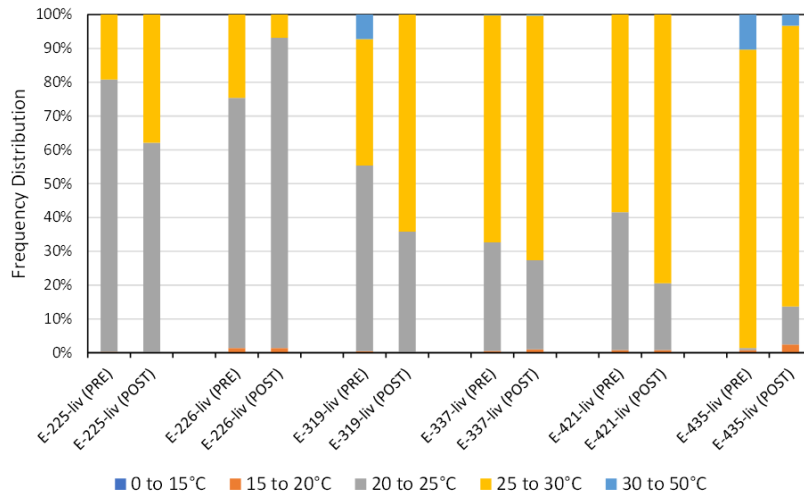
Appendix E.5 – Pre/post-retrofit air temperature frequency distribution for Building E

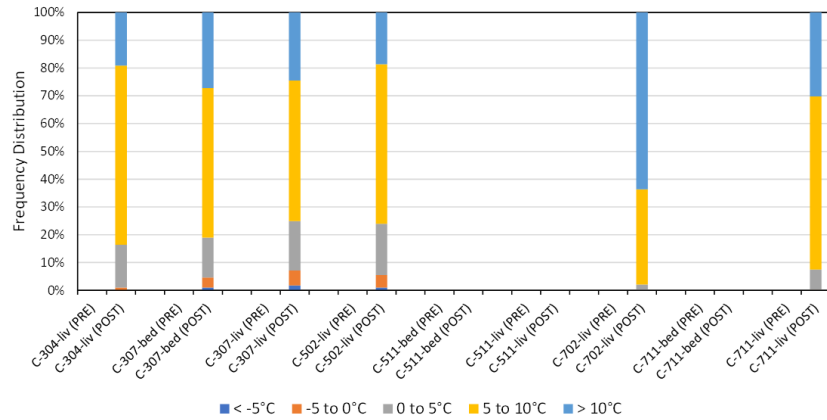
Appendix E.8 – Pre/post-retrofit dew point temperature frequency distribution for Building C between Oct-Mar

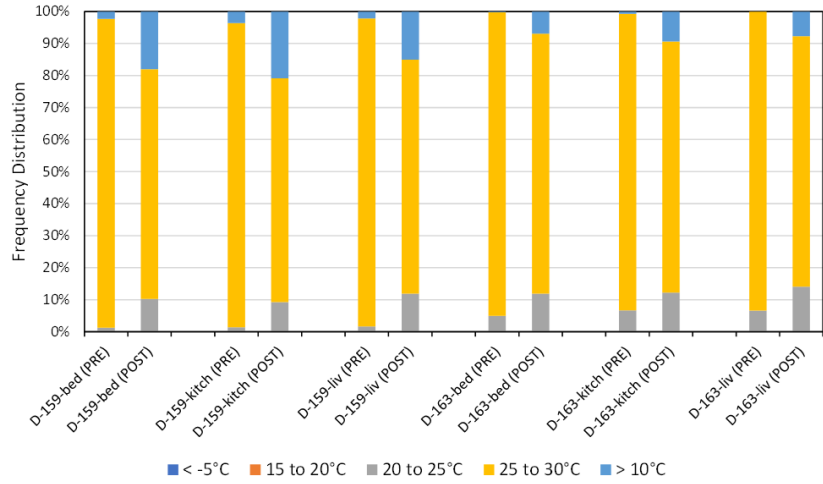
Appendix E.9 – Pre/post-retrofit dew point temperature frequency distribution for Building D between Oct-Mar

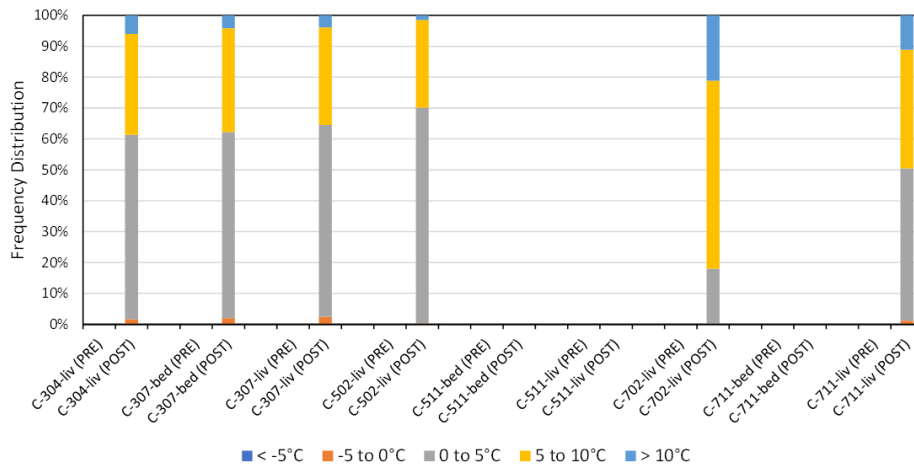
Appendix E.13 – Pre/post-retrofit delta dew point temperature frequency distribution for Building C between Oct-Mar

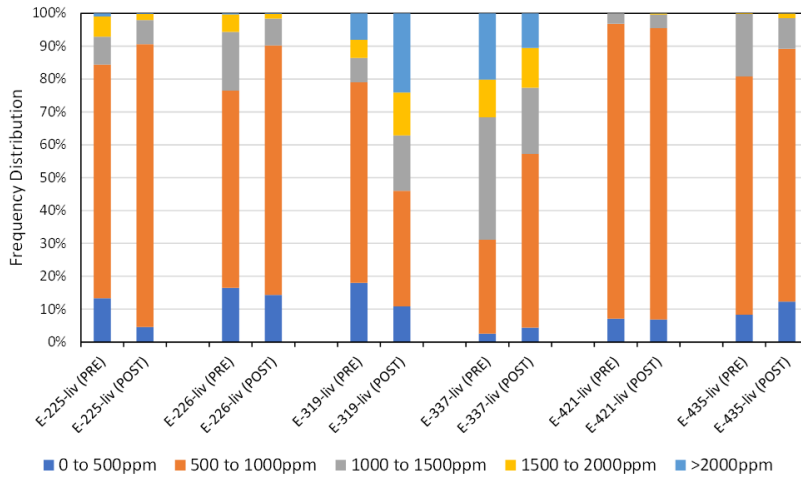
Appendix E.20 – Pre/post-retrofit carbon dioxide concentration frequency distribution for Building E
